BY DAVID J. WELCH AND DON BUCK

LOOKING WEST

Trail Classifications

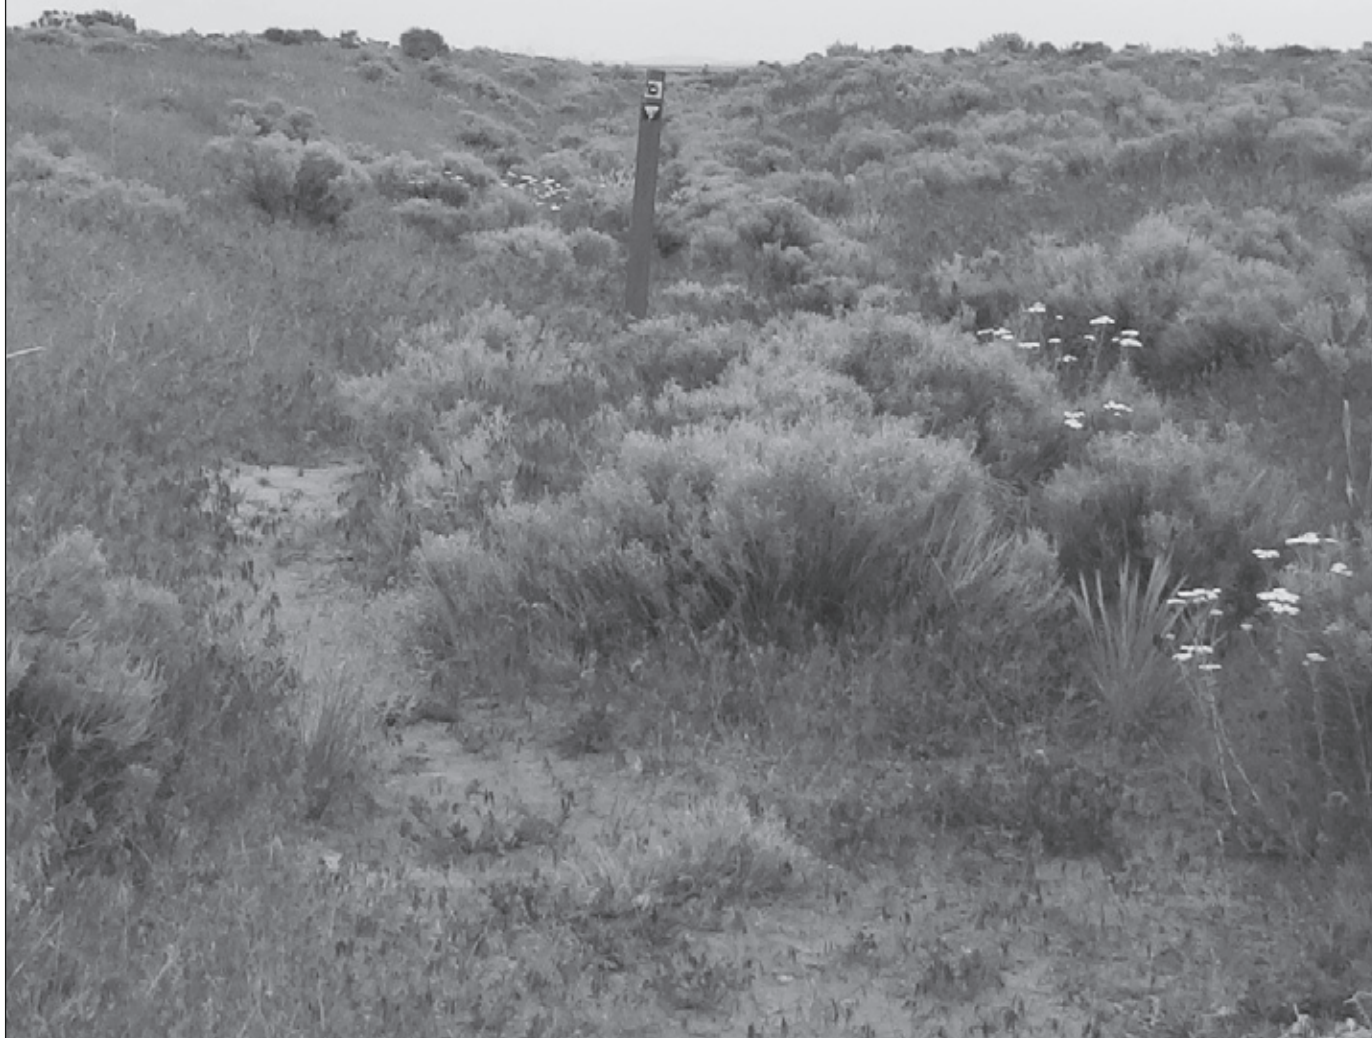
On page 133, Class 1 segment on the Oregon Trail at Echo Meadows, Oregon. Photo by David Welch.

The trail segment retains the essence of its original character and shows no evidence of having been substantially altered by motor vehicles or by modern road improvements. There is visible evidence of the original trail in the form of depressions, ruts, swales, tracks, scarring, vegetative differences, rock alignments along the trailside, and eroded trail features.

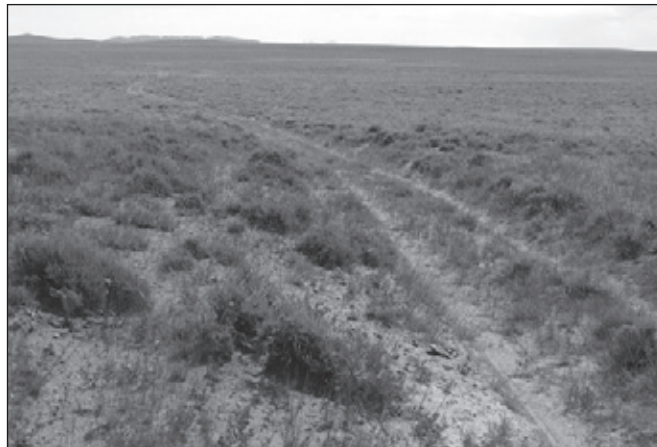
Above, Class 2 trail east of South Pass, Wyoming. Photo by Randy Wagner.

The trail retains the essence of its original character but shows past or present use by motor vehicles, typically as a two-track road overlaying the original wagon trail. There is little or no evidence of having been altered permanently by modern road improvements, such as widening, blading, grading, crowning, or graveling. In forested areas the trail may have been used for logging but still retains elements of its original character.

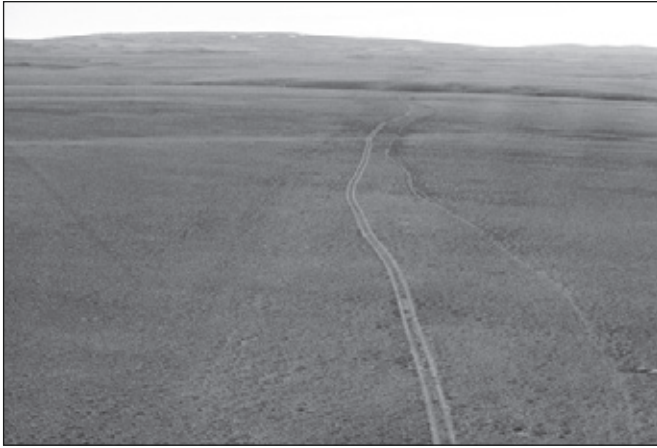
A Class 2 trail within a broad Class 1 swale near the Big Sandy in Wyoming. *Photo by Randy Wagner.*

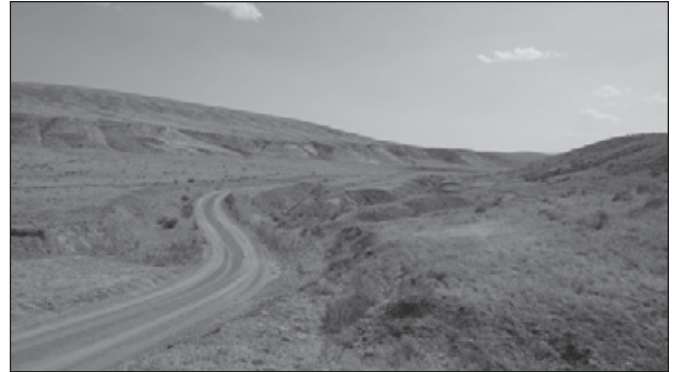
Class 4 trail north of Vale and Tub Springs in Oregon. *Photo by David Welch.*

The trail location is verified but elements of its original condition have been permanently altered, primarily by road construction, such as widening, blading, grading, crowning, graveling, or paving. In some cases, the original trail has been permanently altered by underground cables and pipelines. In other cases, trail segments, whose locations are verified, may have been destroyed by natural events or modern developments, leaving no evidence of their original appearance.
