**THE BECKWOURTH EMIGRANT TRAIL:
USING HISTORICAL ACCOUNTS TO GUIDE ARCHAEOLOGICAL FIELDWORK
IN THE PLUMAS NATIONAL FOREST**

ANGEL MORGAN
LASSEN NATIONAL FOREST, ALMANOR RANGER DISTRICT

KAREN MITCHELL
PLUMAS NATIONAL FOREST, FEATHER RIVER RANGER DISTRICT

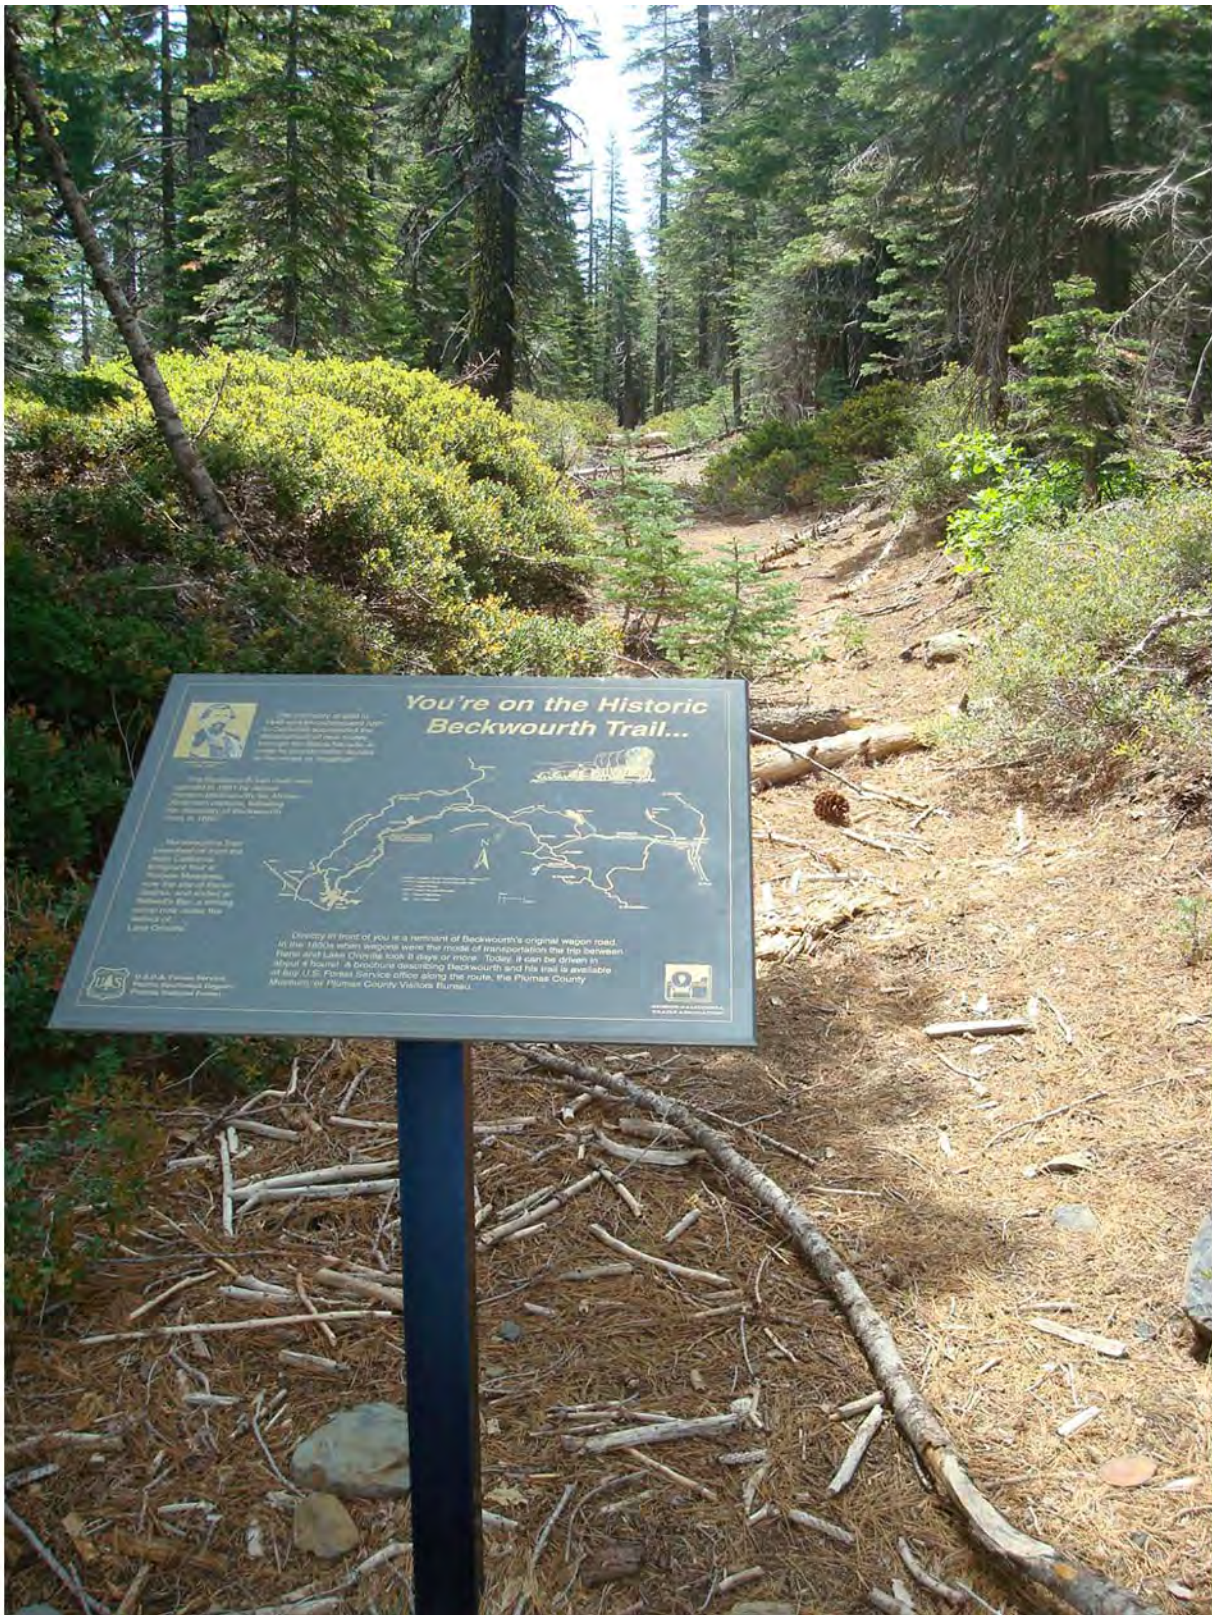
Category 1: The trail retains the essence of its original condition. It is visible as ruts, swales, dirt side berms, stacked linear alignments, or other scars. This category is equivalent to OCTA's Class 1 (Figure 3).

Figure 3: Category 1 -- Segment 6. (Note: All photos taken by Forest Service crew during the 2009 field Season, FRRD, Plumas National Forest.)

Segment 6 runs northwest to southeast, parallel to the Oro-Quincy Highway. The northernmost point begins at the entrance of Four Trees, and the southernmost point intersects the highway. The segment is 1,160 ft. long. It has an 8.5-ft. bottom width and 2-ft.-4-in. depth. Stacked rocks and boulders line the sides of the trail. It is also partially covered with gravel. There is a parallel segment 26 ft. to the west, which has smaller berms. The construction of the Oro-Quincy Highway destroyed the south side; likewise, construction of FS 23N28 destroyed the north side. This segment was classified as Category 1. The associated resources include wire and cut nails and two wooden posts, one with wire nailed to it and the other with drill holes. The northern side is discernible by a Trails West marker.

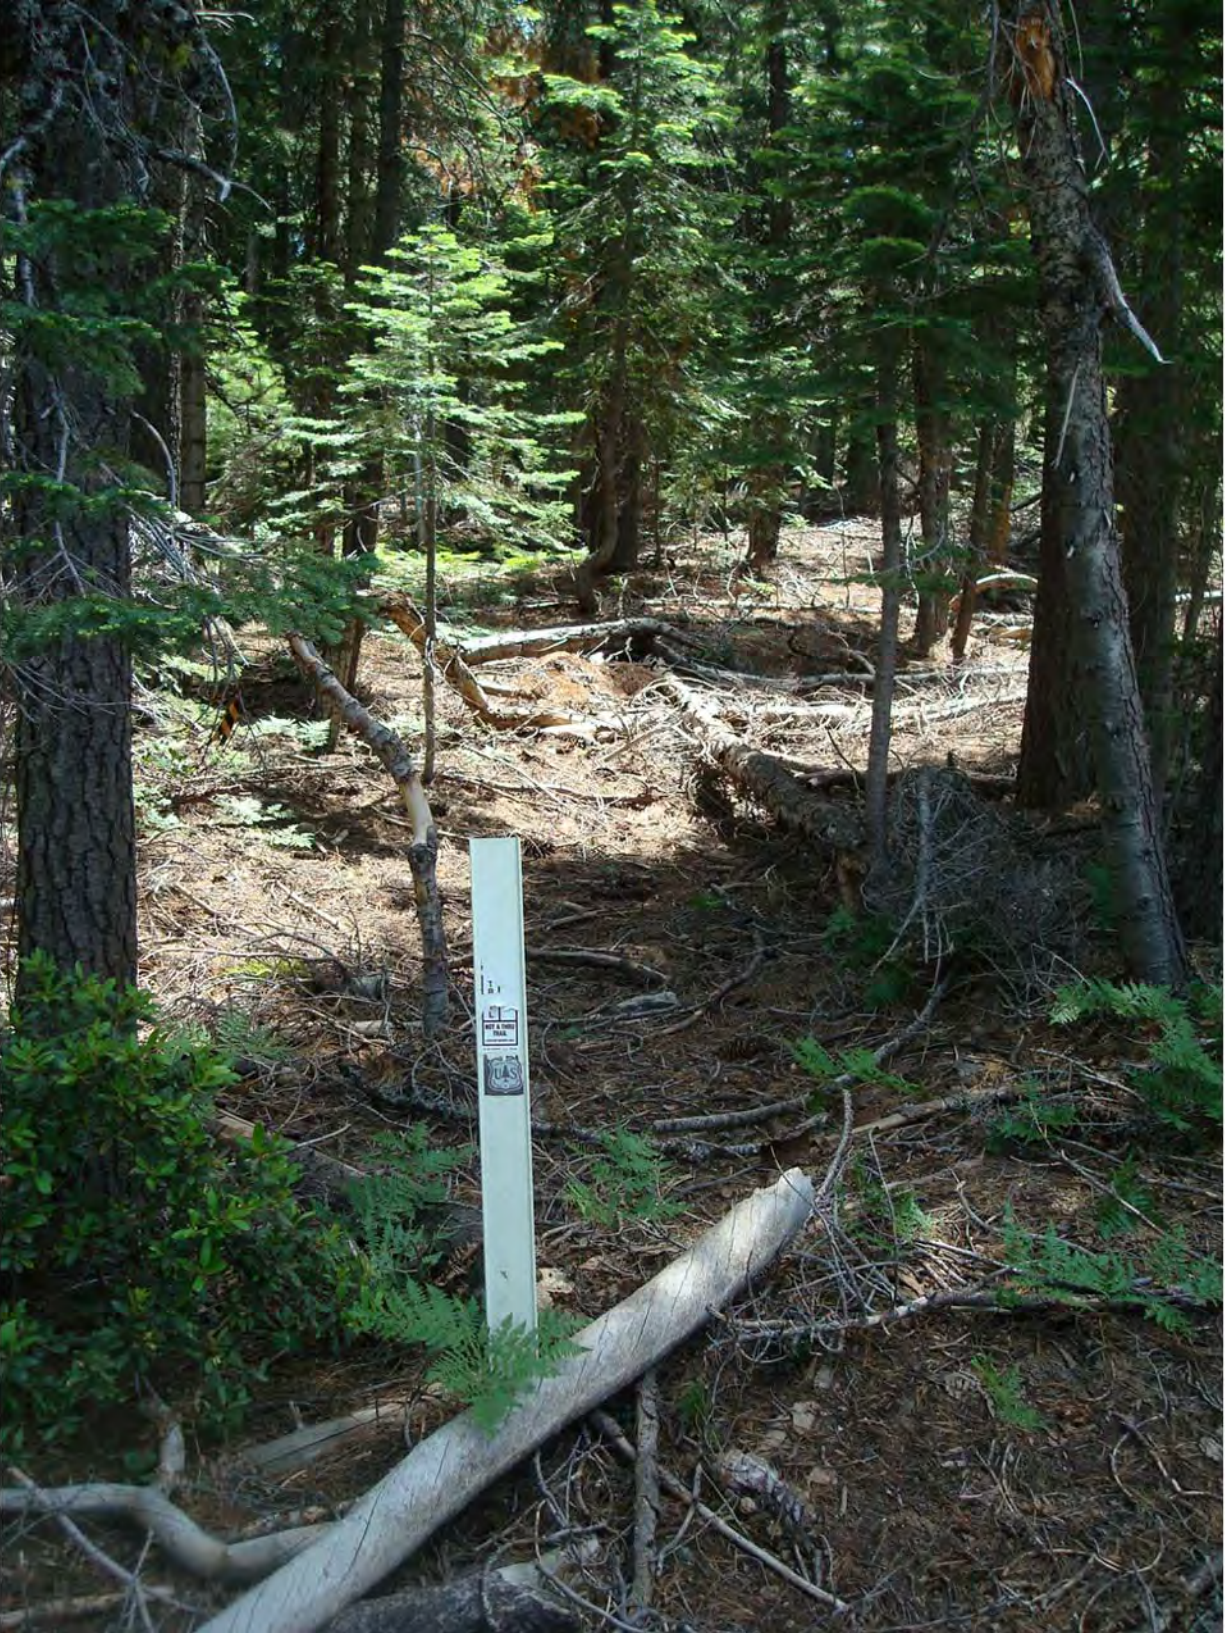
Category 2: The trail is evident, but it has been subjected to light vehicle use. This category is equivalent to OCTA's Class 2 (Figure 4).

Figure 4: Category 2 -- Segment 13.

Segment 13 is on the east side of the Oro-Quincy Highway, across from FS 23N08X. This segment consists of a shallow cut into the north side of the hill. There are small granite boulders strewn along the side of the trail. It is 426 ft. long, has a bottom width of 8 ft., and has a depth of 1 ft. 5 in. The southern edge disappears into the brush, and the northern edge was destroyed by the construction of the Oro-Quincy Highway. This segment was classified as Category 2 because logging activities heavily impacted it. An OCTA trail marker sits on the north side. There were no associated resources found at this location. The segment matches the 1870 notes by Battelle for T23N R6E section 21.

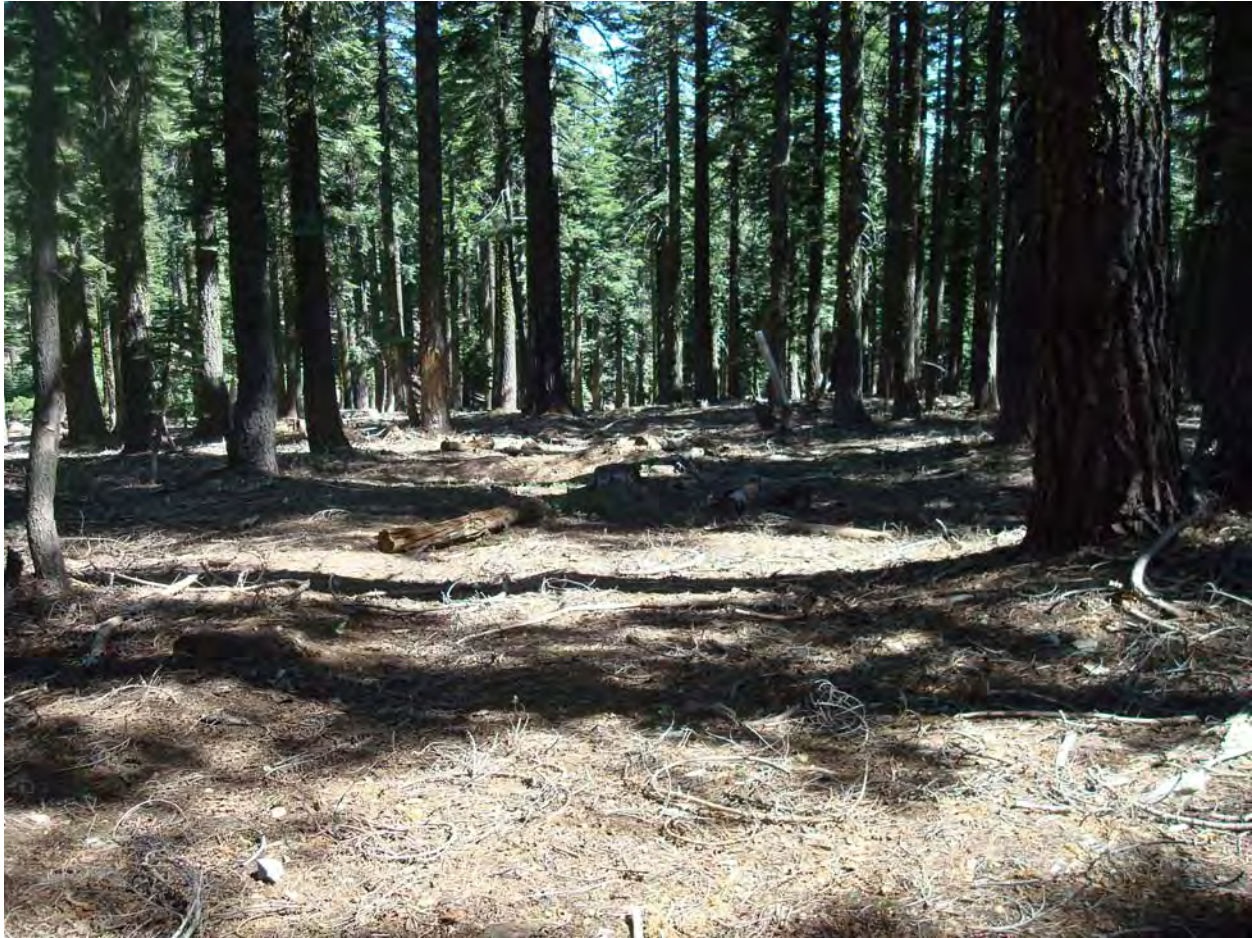
Category 3: The route is assumed, but the traces are nonexistent or insignificant. This category is a combination of OCTA's Class 3 and Class 5 (Figure 5).

Figure 5: Category 3 -- Segment 17.

Segment 17 lies south of the Oro-Quincy Highway between FS 23N95Y and FS 23N85Y, and continues along the ridge. There is no evidence of berms or other historic trail features. A considerable amount of logging damage is present; therefore, it was difficult to determine whether or not this section is actually part of the Beckwourth wagon road. The trail is 908 ft. long, has a bottom width of 13 ft., 8 in., and has a depth of 1 ft. Logging activity destroyed both the northern and the southern edges. This segment was classified as Category 3. An OCTA trail marker is present on the southeast side. There were no associated resources found at this location. The segment matches the 1870 notes by Battelle for T23N R6E sections 12 and 13.

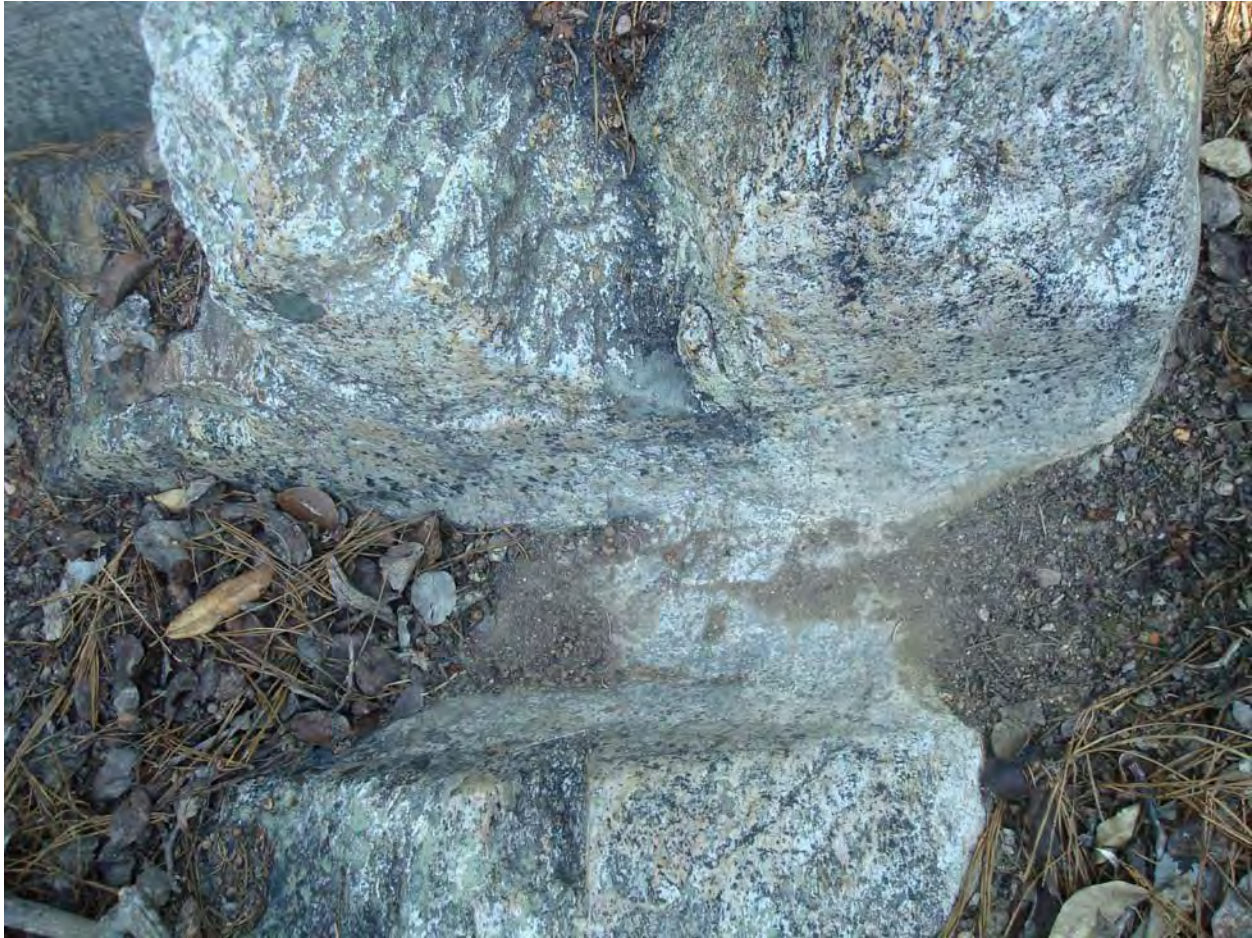
Figure 7. Wagon ruts in soapstone. Segment 9.

Segment 9 lies on the east side of the Oro-Quincy Highway, beginning just south of Frog Rock. The trail is 2,556 ft. long, has a bottom width of 8 ft., and has a depth of 5 ft. 5 in. The southern portion of the trail consists of a deep swale, which has been integrated into an Off-Highway Vehicle (OHV) trail. The middle part of the segment is flatter and less visible, but it becomes more prominent further north, where there is a large wagon rut in the soapstone (Figure 7). There is modern cutting in the soapstone as well. This segment is aligned with OCTA markers, and a Trails West marker was placed on the northern edge. It was classified as Category 2 due to the OHV use. Both sides were destroyed by the construction of the Oro-Quincy Highway. There were no associated resources found at this location.
