Helen Delight Stone for the degree of Masters of Arts in Applied Anthropology presented on June 11, 1997. Title: The Archaeology of the Smith House (ORYA3), Dayton, Oregon.

Site ORYA3, the Smith House, is located in Dayton, Oregon. The archaeological project originated because owners of this structure, listed on the National Register of Historic Places, applied for a demolition permit. The 1859 home, first occupied by two early Oregon pioneers, Andrew and Sarah Smith, was considered architecturally significant, an unique example of a territorial period home. In the years since 1859, the original building construction has not been significantly modified, nor have the grounds been looted or substantially altered. Dr. David Brauner and the Oregon State University Anthropology Department began an archaeological project at this location in anticipation of the destruction, the first time in Oregon that archaeologists have excavated the interior of a standing house.

THE ARCHAEOLOGY OF THE SMITH HOUSE (ORYA3), DAYTON, OREGON

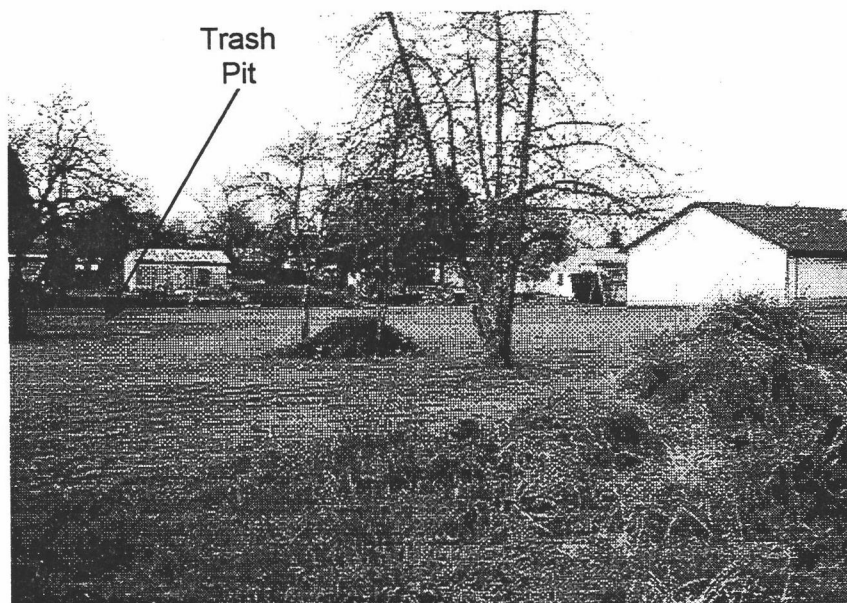
Figure 3.1 1992 Photo of Trash Feature (Research photo on file at Oregon State University)

In Fall 1992 four test pits were sampled in order to define the perimeters of the trash feature. This researcher was not present during the trash feature excavation. Additionally, field notes regarding this phase have not been available to this researcher. The trash feature location is shown in Figure 3.1. The relationship of the trash feature along the historic creek edge is shown in Figure 3.2.

Dr. Brauner excavated one sample pit, testing for horizontal integrity. This pit terminated quickly, being sterile of cultural material. Two sample pits were placed along the creek. A fourth pit was opened, exposing another portion of the trash feature. These three sample pits were then joined together. The material content and definition within the three new pits indicated a single dumpsite. All cultural material unearthed by the archaeologists was removed from the site, with two exceptions. A sampling of brick and toilet porcelain had been kept, and a pile of these was exposed on the ground by the brush clearing.

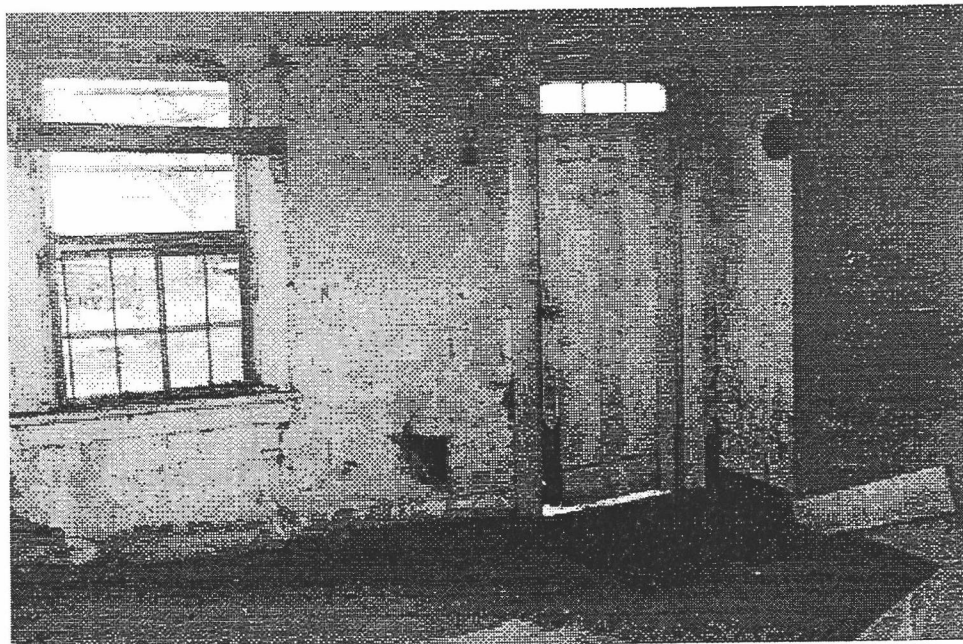
Figure 3.3 1993 Photo of Entry Interior (Research photo on file at Oregon State University)

At the time of excavation the physical condition of the building was described as bad (Olsen, 1991: personal correspondence). Figure 3.3 is a photo of the entry interior demonstrating physical condition. All of the foundation, timber sills, first floor flooring and joists were rotten. At least half the studs needed repair; many were severely damaged. The upper portion of the house was in better shape, with most finish materials in adequate condition. The existing chimneys, due to location and style, were determined not to be originals. The baluster was missing, but pieces of the original were stored in the attic. The front door was not original. Most of the sash remained present and in good shape. The connecting wing was present enough so that it could be accurately rebuilt (Olsen, 1991: personal correspondence). Figure 3.4 illustrates excavation during this period.

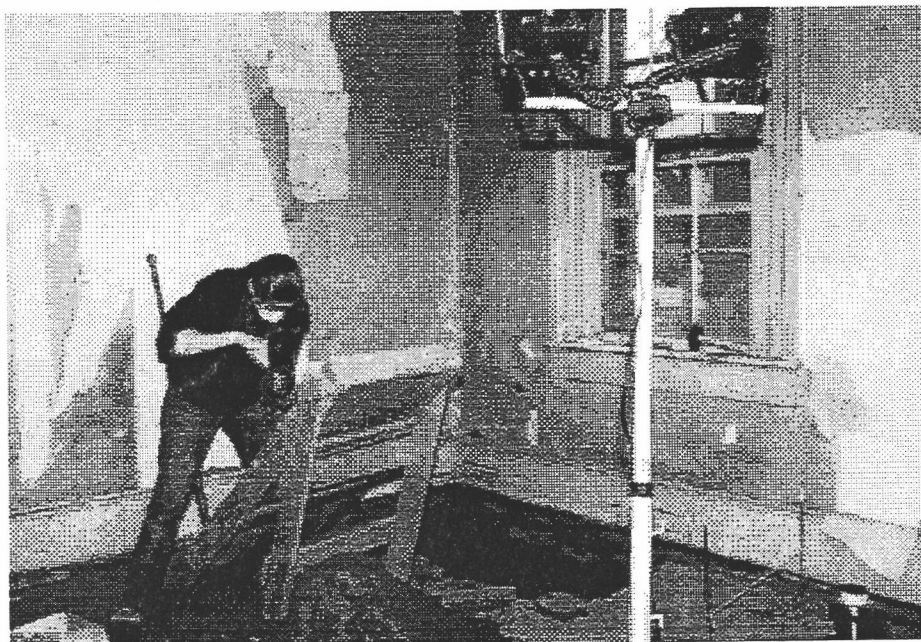
Figure 3.4 1993 Interior Excavation (Research photo on file at Oregon State University)

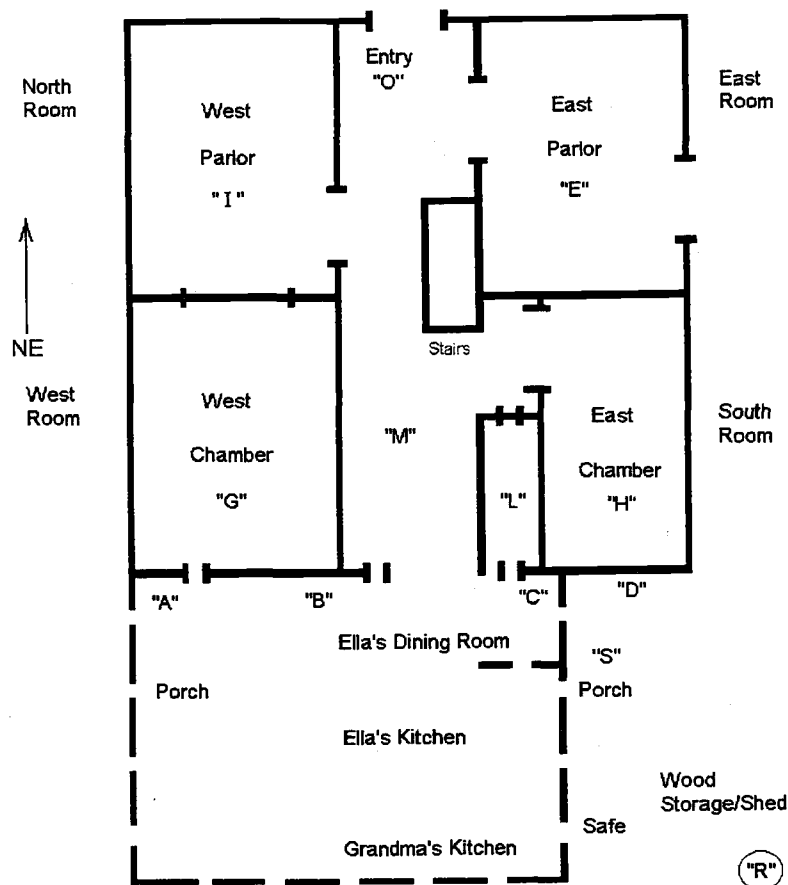
Figure 3.5 Individual Room Association

The method in which artifacts were collected depended on a variety of factors. When the preservation team removed the rotted wood flooring, they placed any cultural materials they found in boxes labeled by individual room: west parlor, east parlor, east chamber, west chamber. Figure 3.5 illustrates these associations schematically.

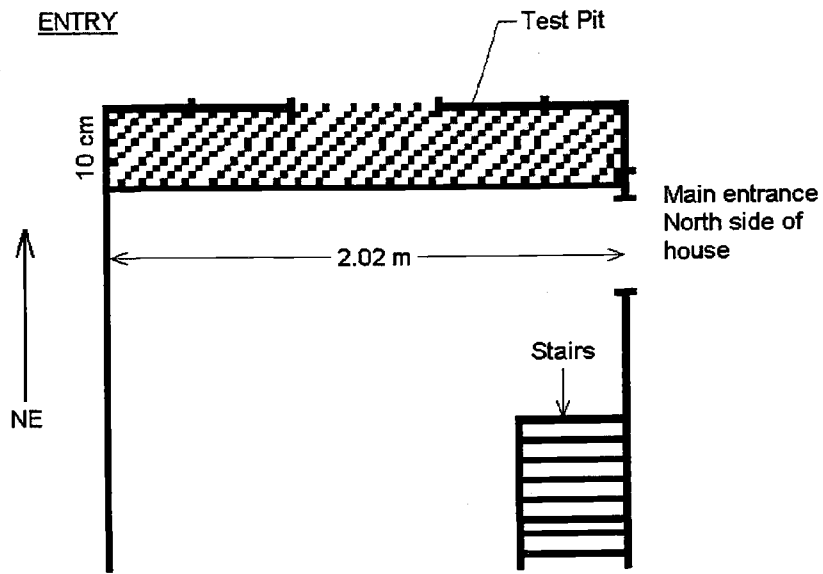
Figure 3.6 Entry Test Pits

It was observed that the soil profile indicated a known single component, or culturally homogeneous stratigraphic unit. It was decided that the collection method would be by test pits. Figures 3.6, 3.7, 3.8, 3.9, and 3.10 indicate test pit locations and pit details.

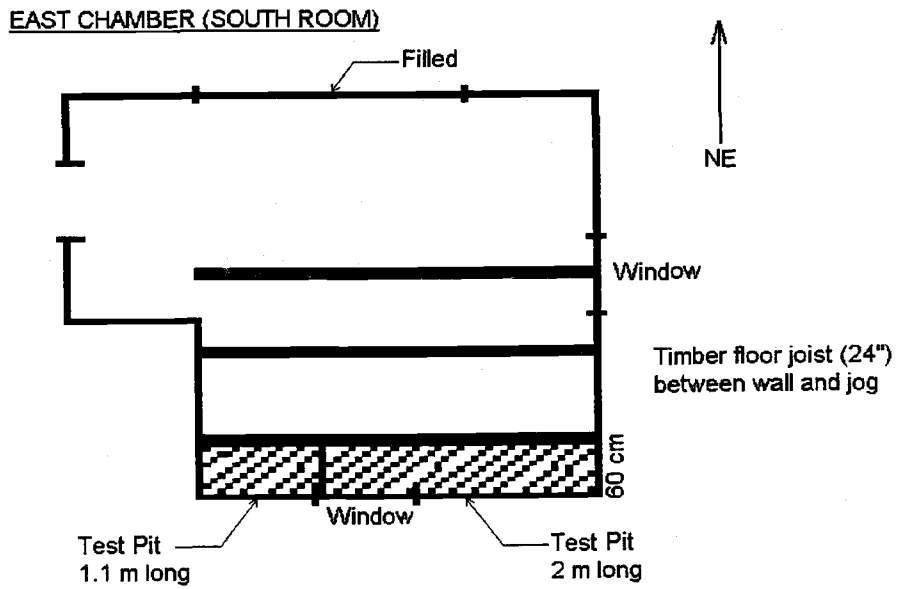
Figure 3.7 East Chamber Test Pits

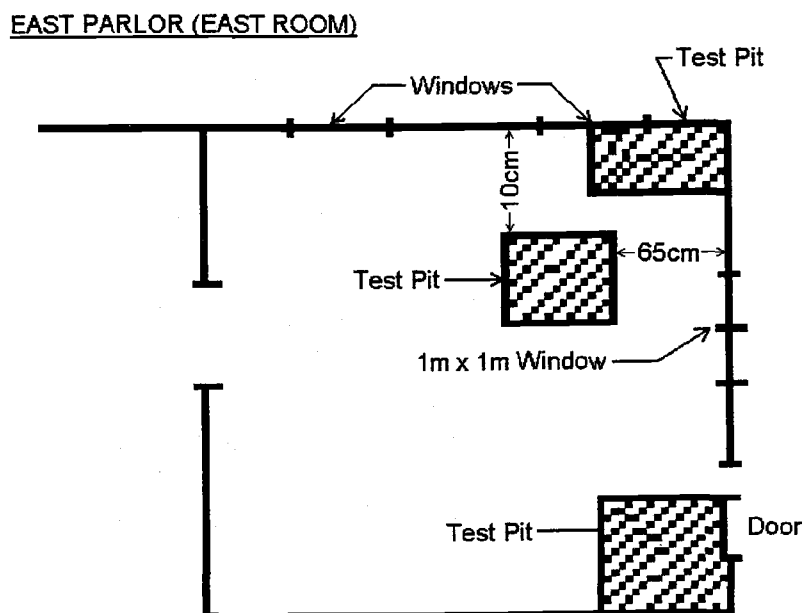
Figure 3.8 East Parlor Test Pits

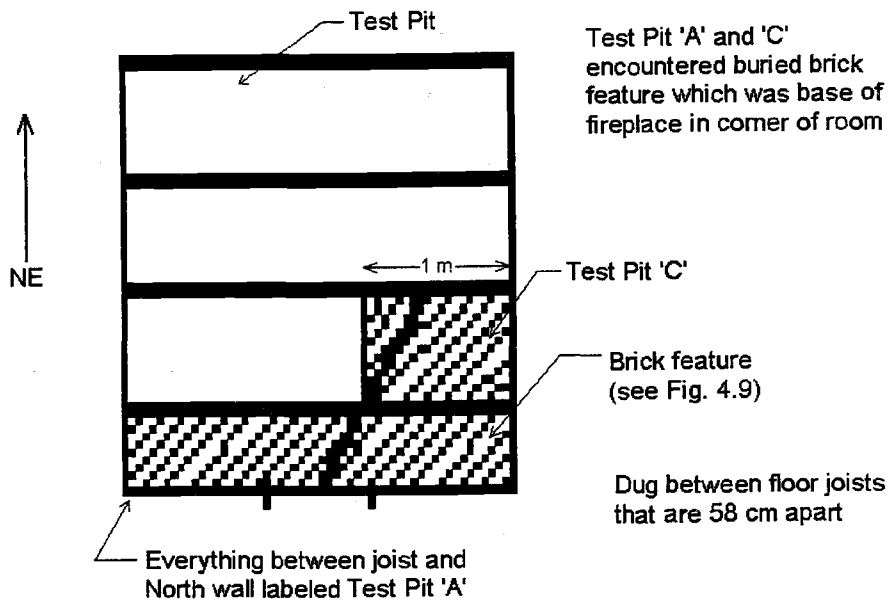
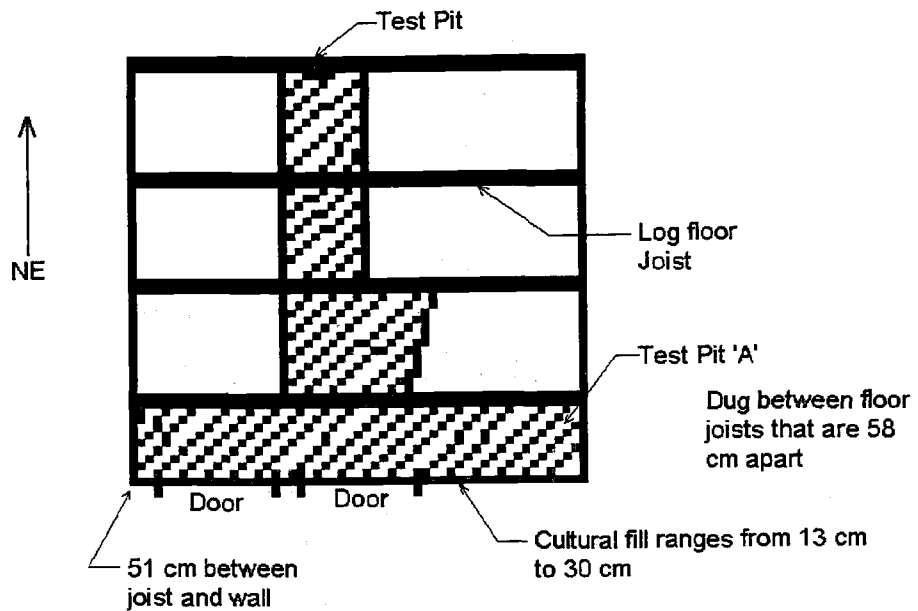
Figure 3.9 West Chamber Test Pits

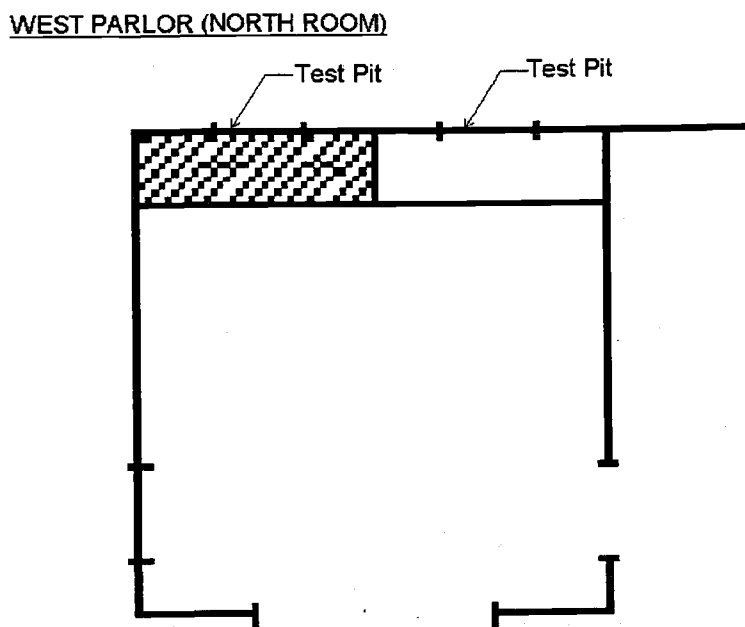
Figure 3.10 West Parlor Test Pits

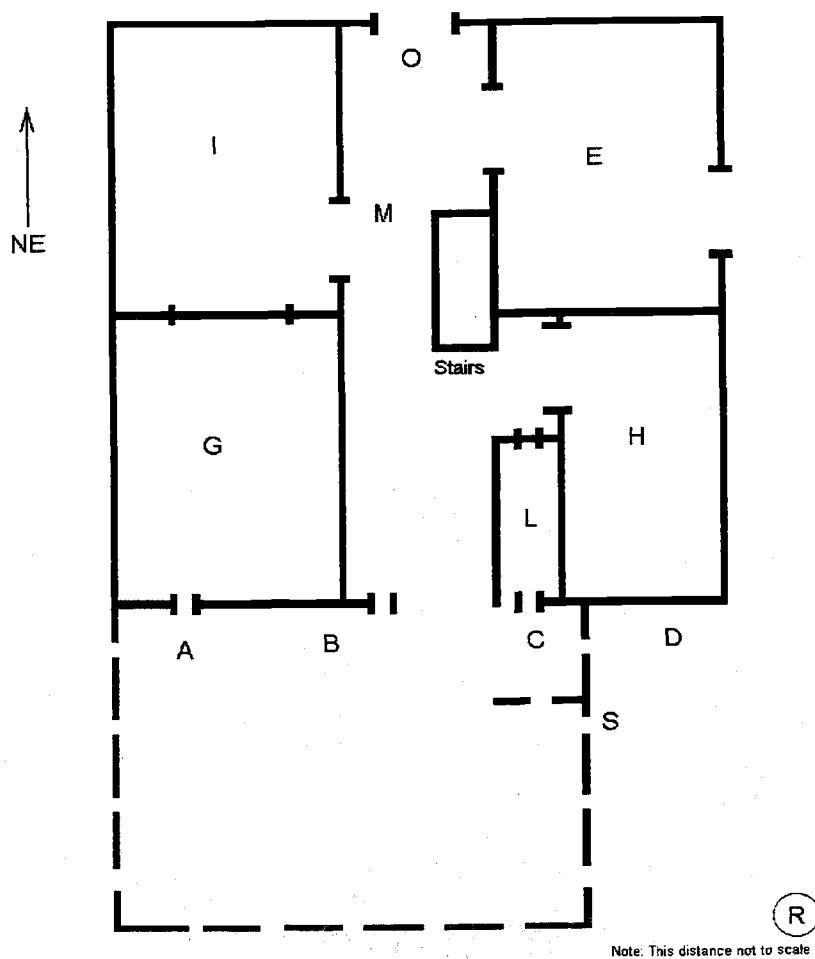
Figure 3.11 Labeled Associated Proveniences

historic SE porch, which was not physically present in the Spring of 1993, is labeled "S".  
The labeled associated proveniences of the pits are shown in Figure 3.11.

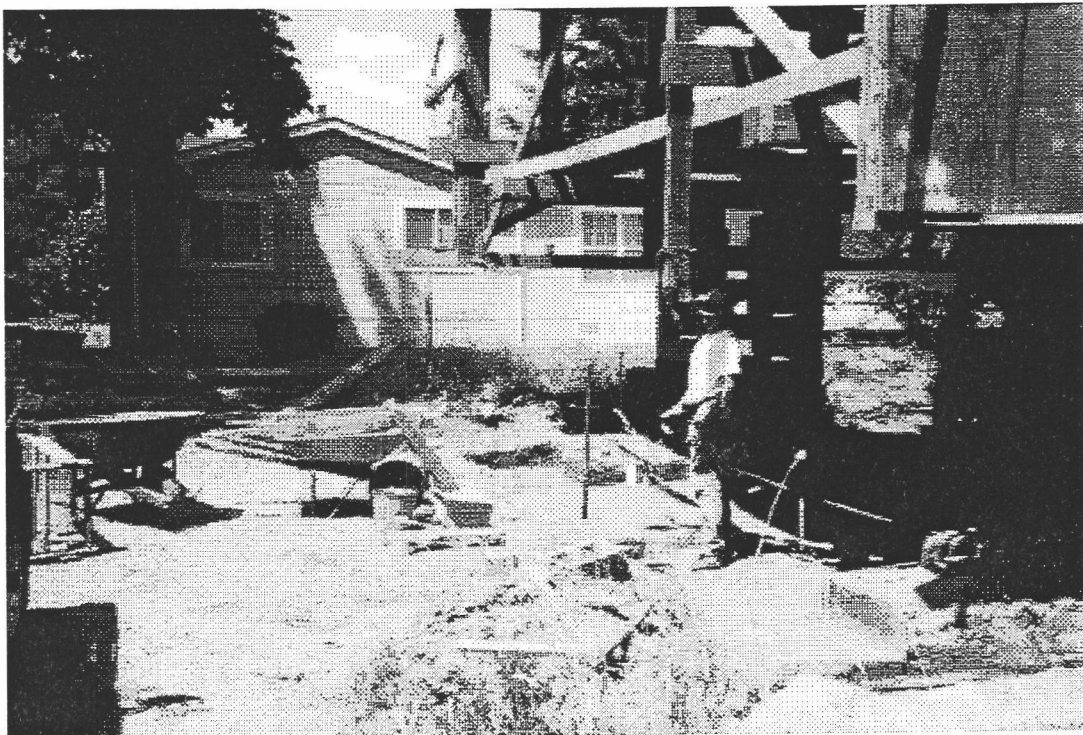
Figure 3.12 Foundation Trench Excavation (Research photo on file at Oregon State University)

Archaeological excavation provided so much cultural material that both preservationists and archaeologists agreed that archaeologists would excavate the new foundation trench running across the southern edge of "G", "L" and "H". Figure 3.12 illustrates the excavation of this foundation trench.

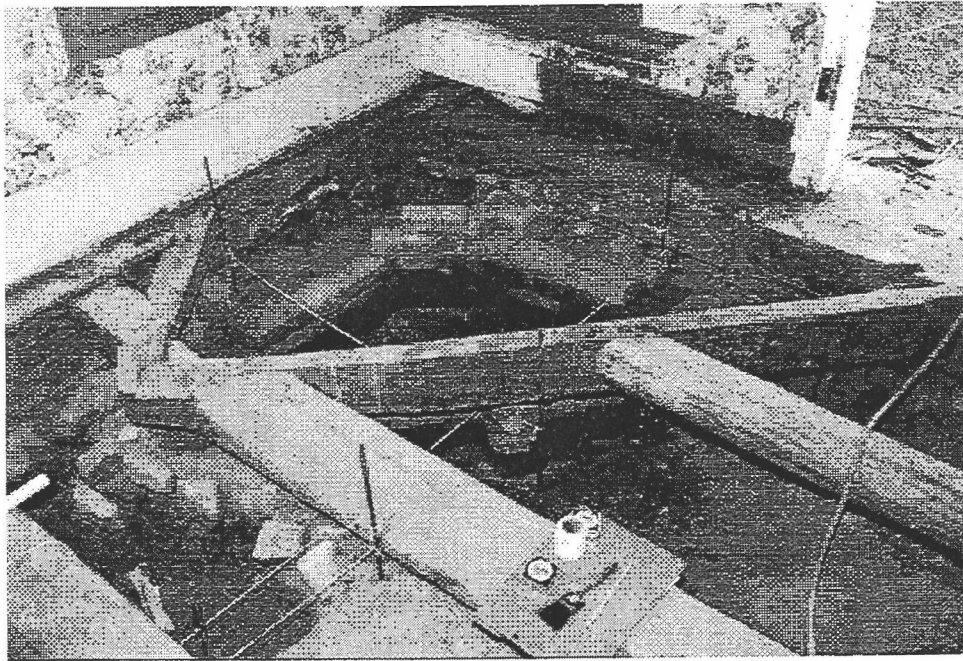
Figure 3.13 Photo of Original Hearth Feature (Research photo on file at Oregon State University)

House features exposed during the course of archaeological sampling included: the base of the house's original fireplace, the hearth, floor footings, pier posts, and foundation fragments. Figure 3.13 and Figure 4.6 illustrate the original hearth of the fireplace. This is material that would not have been recoverable with mechanized construction techniques.

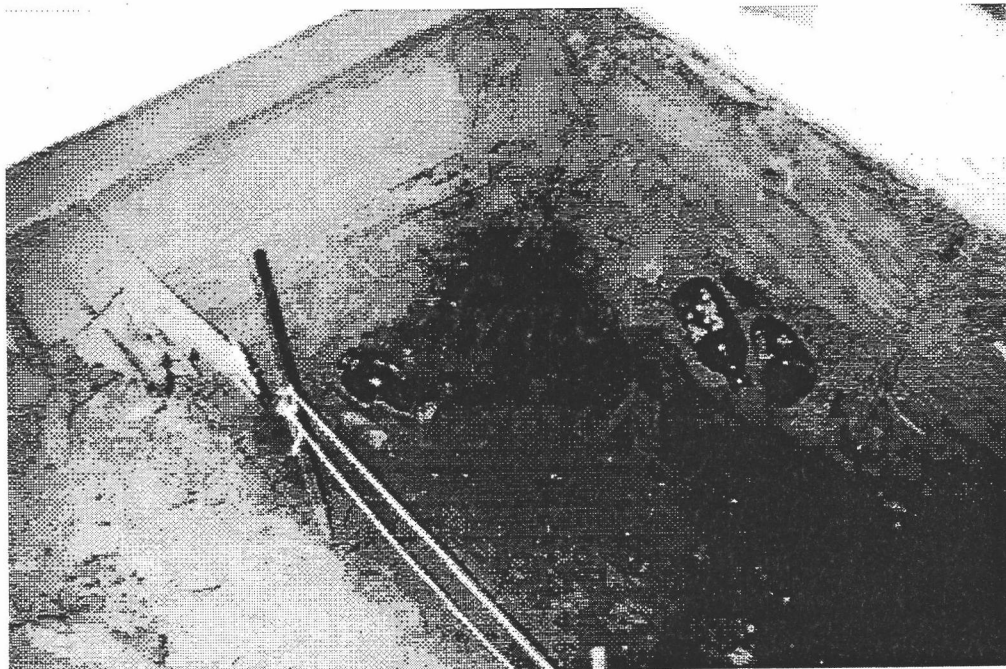
Figure 3.14 20<sup>th</sup> Century Sill Fill (Research photo on file at Oregon State University)

By dating cultural material in sill trenches we were able to establish sequences of construction modifications. Figure 3.14 is a photo of 1960s beer bottles used as sill fill, demonstrating that this particular sill was not placed there in 1859. Additionally, by exposing for view pit wall profiles, we were able to show repetitive repair sequences. This had obvious implications for selection of repair materials. The written detail of this fieldwork is covered in this thesis under specific material type analysis. For example, the brick foundation information is described in the "Brick" section.

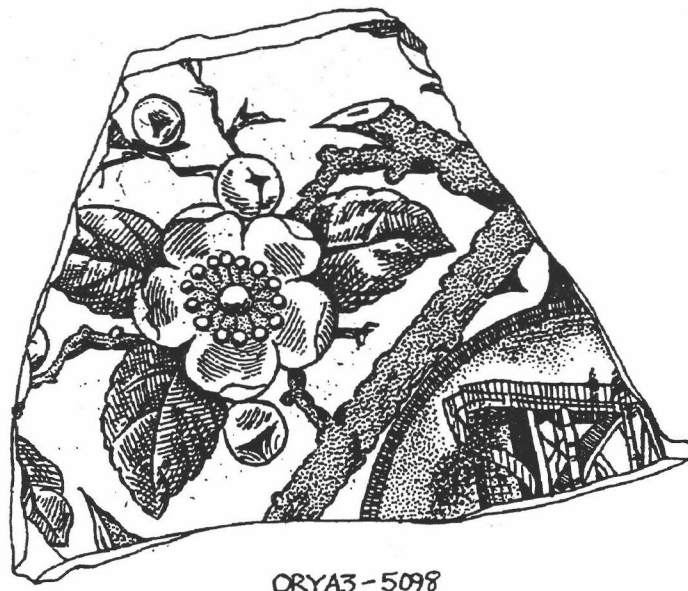
Figure 4.4 Artifact ORYA3-5098 (illustration by Toby White)

vessel fragments of various fabrics. Sets of approximately ten artifacts were given to each of fourteen students for analysis. Students spent four weeks of analysis on their set of ten items. Examples of the ceramics chosen for analysis are the W. E., Hanley, Alaska shards shown in Figures 4.4, 4.5, and 4.6.

- metrically, to include any extrapolated diameters,
- with words, to include fabric type and finish type,
- by vessel type,
- by vessel function,
- by trade mark, manufacturer and date range,
- by transfer pattern, decal, or mold pattern date range, and
- with drawings or Xerox copies.

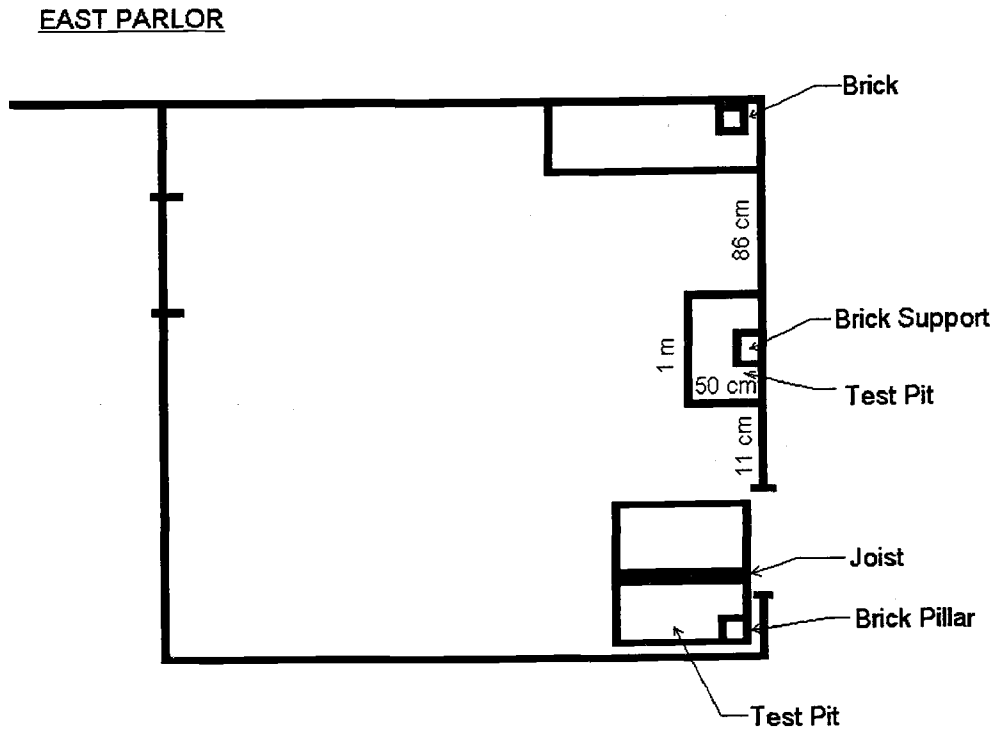
Figure 4.7 Brick in Plan

Associations "O", "M", "L", and "H" did not reveal brick piers. In the southeast corner of "G" (West Room/West Chamber) the archaeologists encountered the remains of a brick firebox and chimney support, defined first by exposing the edges of the feature. Excavating through ash layer two bricks deep, revealed only ash for the three inches depth of the box. Figure 4.9 is the map of the original hearth feature. After mapping, and photographing, bricks were removed and given to the preservation team. Five cm below the brick feature the bottom of the foundation for the firebox was revealed.

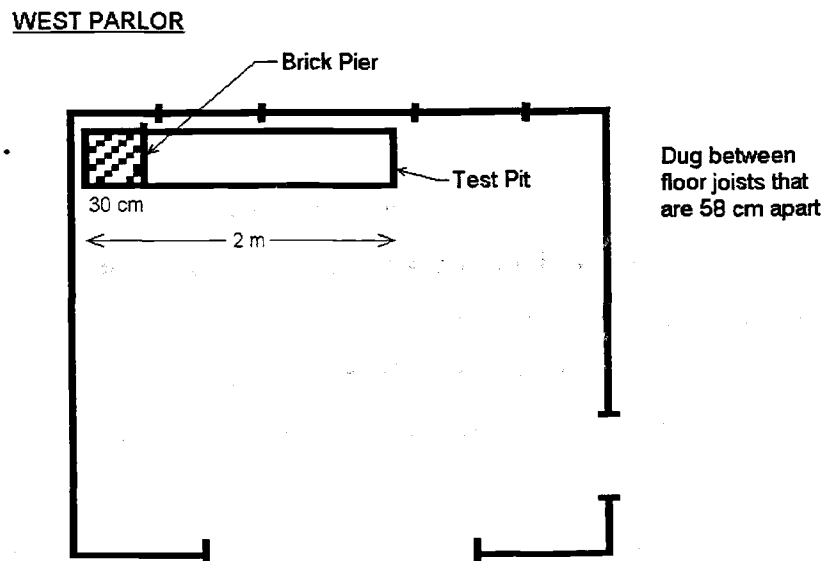
Figure 4.8 Brick in Plan (continued)

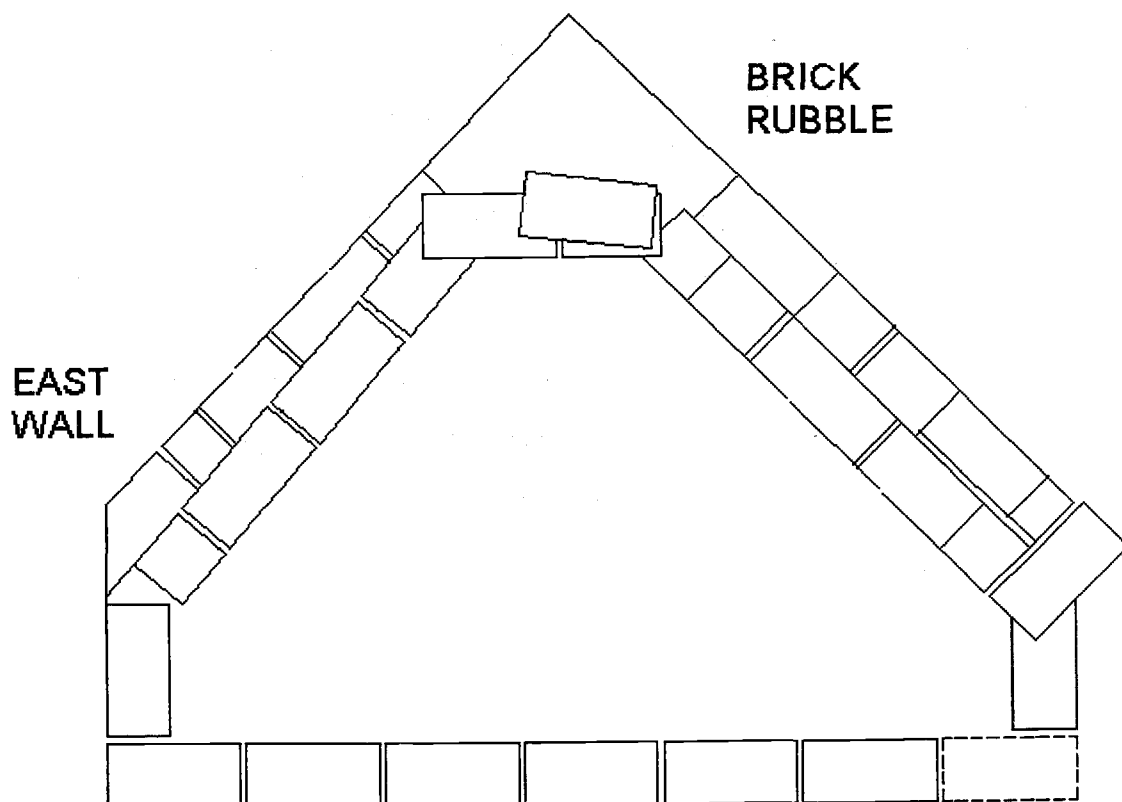
Figure 4.9 Original Hearth Feature in Plan
