Cultural Resource Reports No. 3 - Archaeological Investigations at Cow Hollow Park (35-ML-1416), Nyssa, Oregon

ARCHAEOLOGICAL INVESTIGATIONS AT COW HOLLOW PARK (35-ML-1416), NYSSA, OREGON

Cultural Resource Reports No. 3

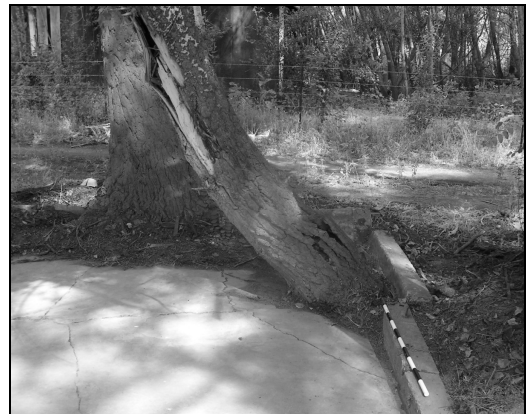
Figure 7. Northeast Corner of Foundation Showing Intrusion.

The remaining structure from the CCC era is, as noted, located on the northeastern corner of the park and overlaps a parcel of private land. In addition, a stone foundation is present opposite the structure to the south. At the time of investigation much of the area was covered by thistle and heavy leaf fall with aspen and locust trees intruding into and uprooting the foundation (see Figure 7).

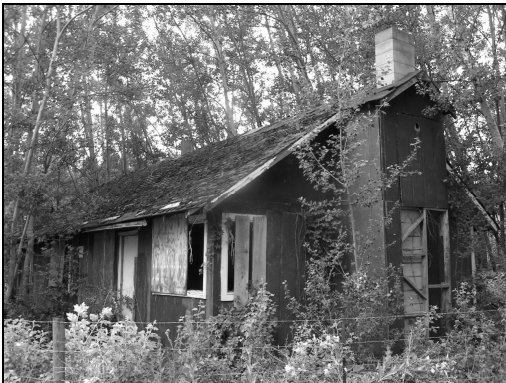
Figure 8. Photograph of Historic Wooden Structure Facing North.

Constructed in 1935, the building is an historic rectangle plan, wood frame structure with a concrete foundation (Figure 8). The roof has a front and back gable, the south half of the roof constructed of wood shake shingles and the north half with wood shake shingles covered with asphalt shingles. The building, clad in wood siding, has some deteriorating sections of composite fiberglass siding added since its original construction. The windows are of wood frame construction and are a combination of casement and picture windows. There are two single wood door entryways, one at the eastern end of the south elevation and one on the northern elevation. There is a combination brick and concrete block chimney at the east elevation of the building.

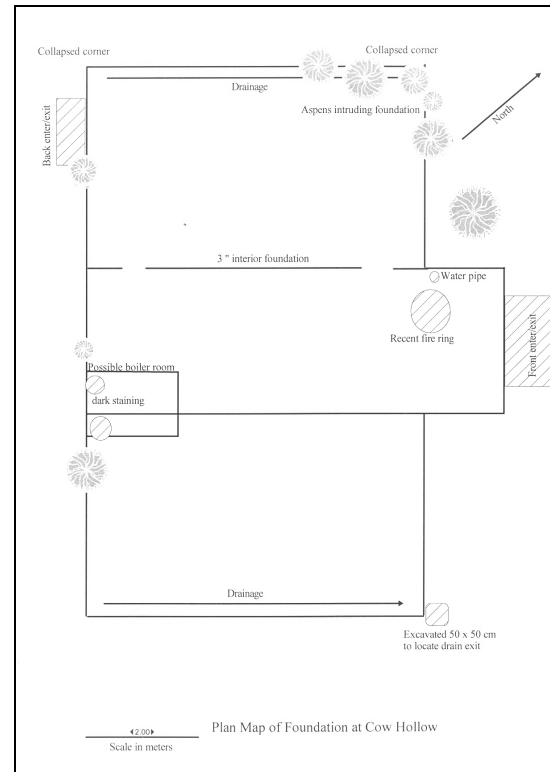
Figure 11. Plan Map of Foundation.

Leaf litter and branches, grass clippings, and trash from what appears to have been hearth fill dumped onto the foundation from historic fireplaces located throughout the park had accumulated to a thickness of 8-12 inches with weeds growing from cracks in the foundation floor. Upon removal of this debris, the foundation was measured and mapped. A recent fire-ring composed of concrete blocks was exposed on the east side of the foundation as were foundation footings, a rectangular room division, a possible boiler or heater area, and locations of the water drains (Figure 11).

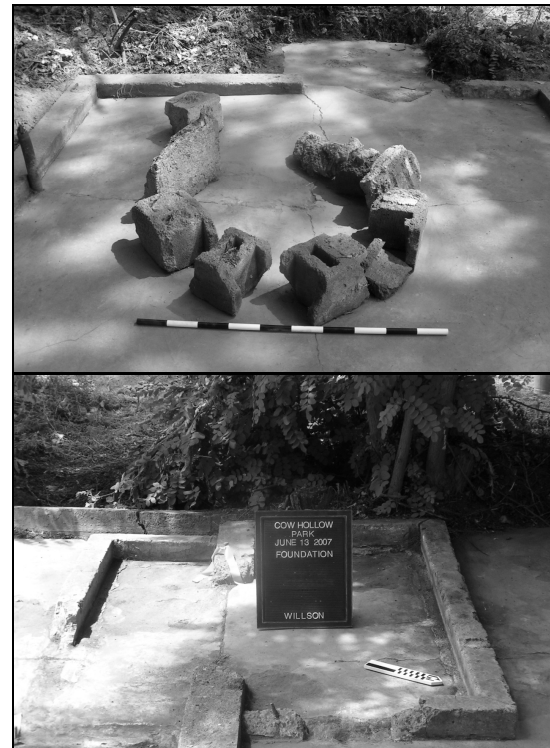
Figure 12. (Upper) Recent Historic Fire Ring; (Lower) Interior Foundation Enclosure.

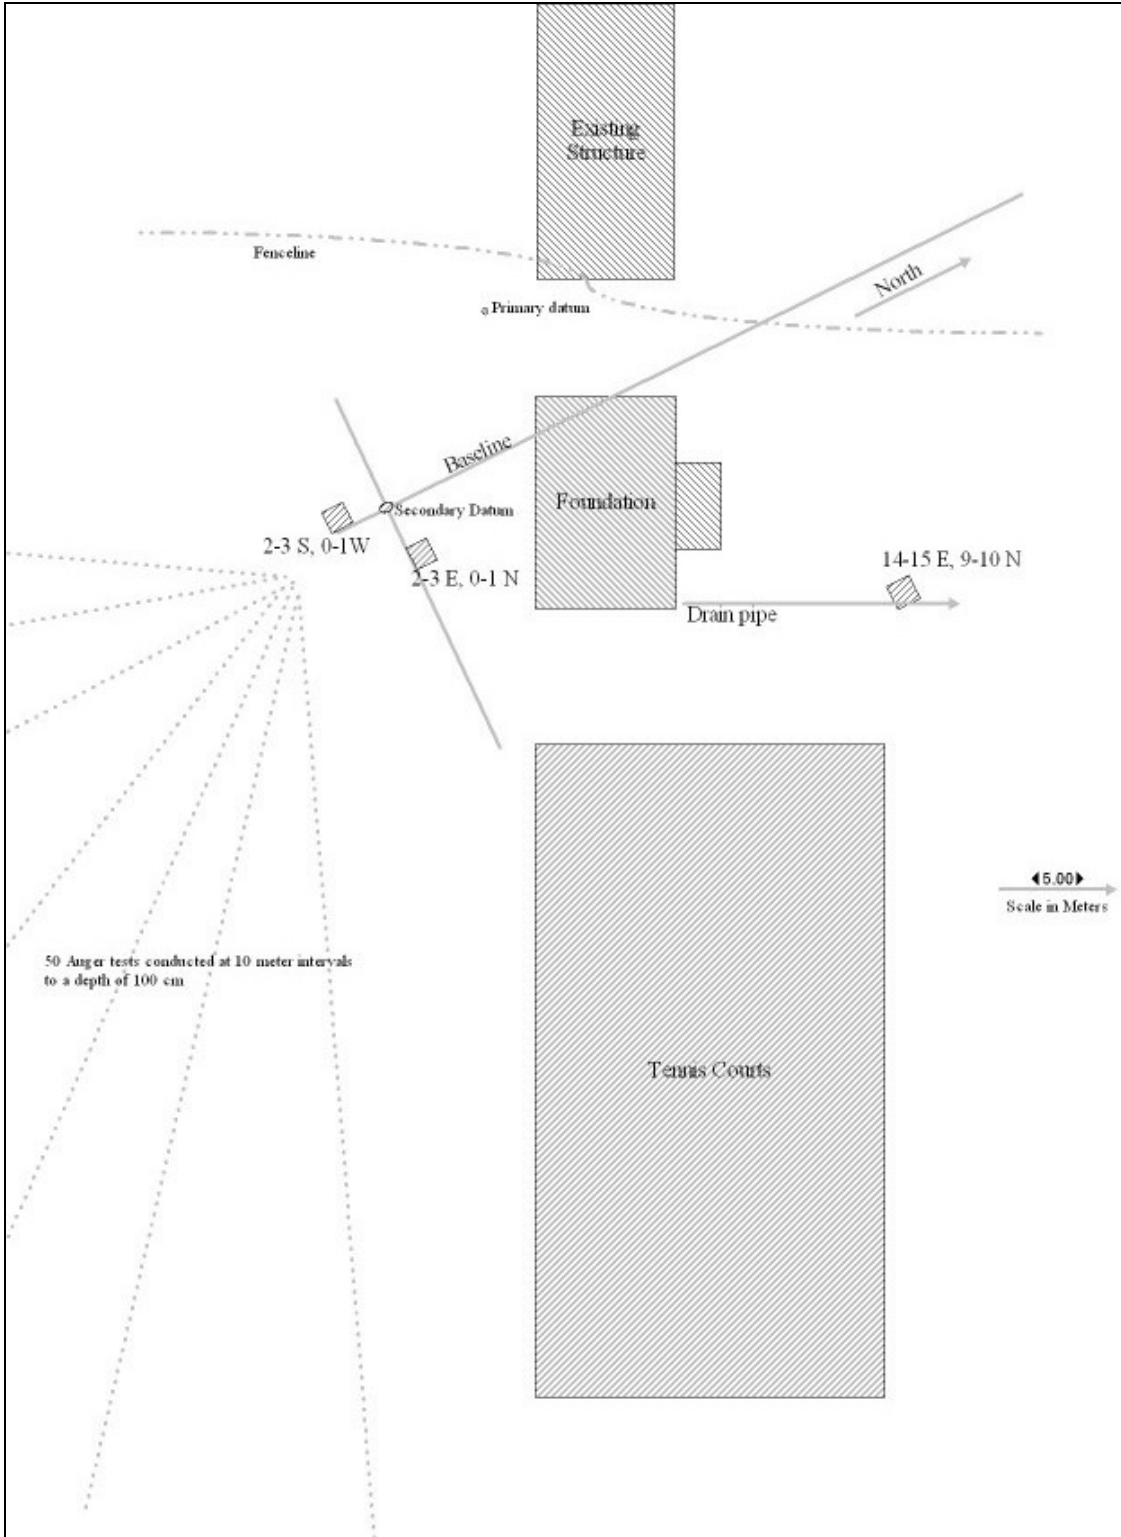
Figure 13. Plan View of Excavation and Core Tests.

datum located on the northeast corner of the park near the existing structure. Unit depths ranged between 80-100 cm (Figure 13 and Table 1). Sediments were compact, uniform silts with consistent color and texture. None of the 50 cores produced cultural material.

A primary datum was placed on the western edge of the foundation south of the existing structure (Figure 13). A secondary datum was positioned 13 meters, 130 degrees southeast, and a north-south baseline was established. Based on the initial survey and auger tests, three 1 x 1 meter test units were established and excavated 2-3S, 0-1W, 2-3E, 0-1N, and 14-15E, 9-10N of the baseline. Each unit was excavated to a depth of 50 cm. Units 2-3S, 0-1W and 2-3E, 0-1N contained

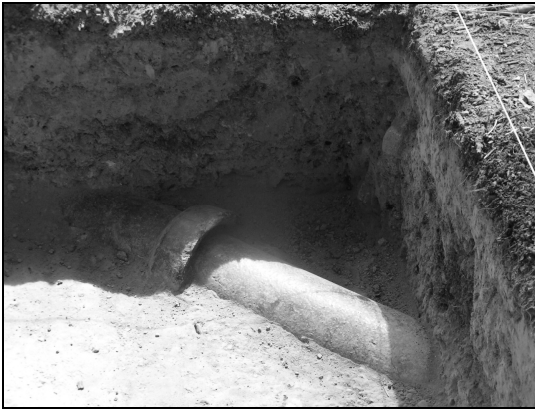
Figure 14. Drain Pipe Connecting to Southeast Corner of Foundation.

The third test unit, 14-15E, 9-10N, contained a few glass and rusted metal fragments. A drain pipe that bisects the southeastern corner at a depth of 34 cm connects to the interior drain of the foundation area (Figure 14). With the exception of the drain pipe, very few cultural items were recovered and no diagnostic items were located.

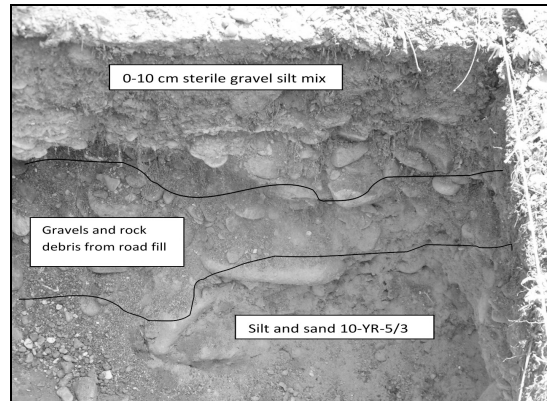
Figure 15. Stratigraphy, Unit 9-10 East, 14-15 North.

The general stratigraphy is compacted silts intermixed with sand. The upper lenses (surface to 10 cm) contain organic materials such as degrading leaf litter and rootlets from weeds and grasses. In units 2-3E, 0-1N, and 2-3S, 0-1W, the sediments are gravels and cobbles, likely from road construction and maintenance. These units are largely sterile of any cultural items. Unit 9-10E, 14-15N was comprised of sterile silts, compacted and intermixed with sand. Munsel readings (10YR-3/3) observed at all levels suggest a uniform deposition.

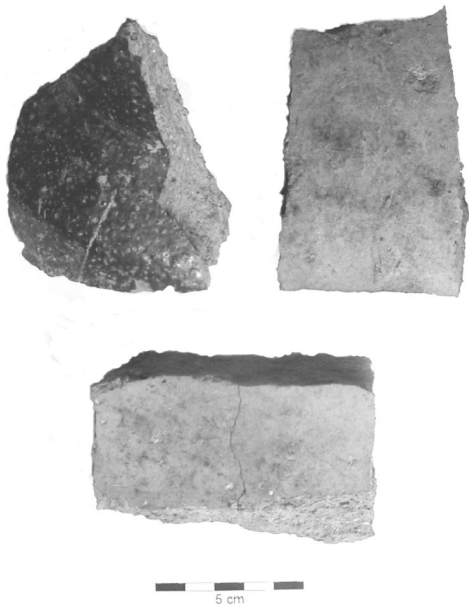
Figure 17. Drain Pipe Fragments.

The artifacts recovered during the investigation cannot be directly associated with either the CCC camp or the internment camp. Of the 29 artifacts recovered, 25 were recovered on the surface adjacent to the foundation. It is likely that most of these artifacts result from recent use of the area and subsequent dumping as evidenced by trash that included plastic bags, aluminum cans, and items dating no earlier than the 1970s. Drain pipe fragments (n=4) recovered on the surface in unit 14-15N, 9-10E, and in shovel probe 7 are thought to be associated with shower or laundry drainages (Figure 17).

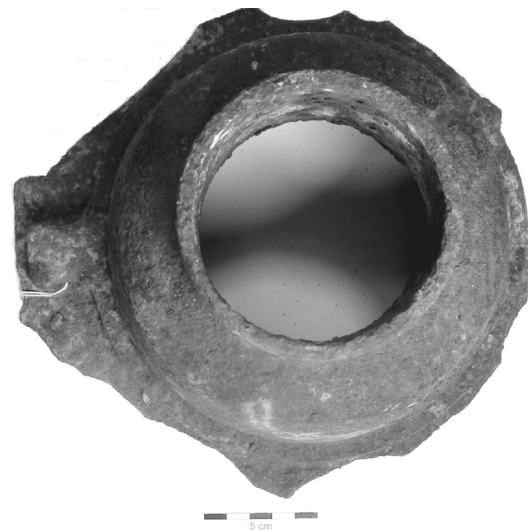
Figure 19. Shower/Toilet Flange.

Metal items include fixtures, a light shade, a car jack base, and a toilet flange (Figure 19). Two nails, a rusted bolt, a metal spike, and miscellaneous rusted metal objects were

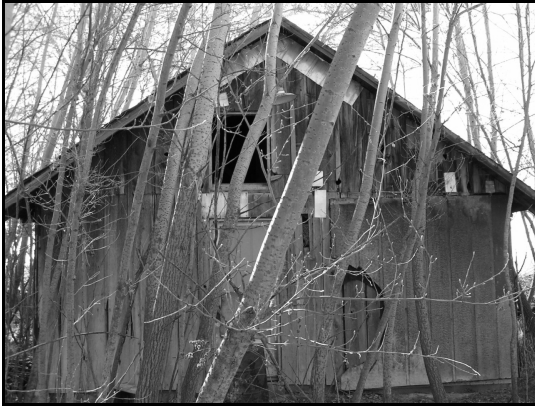
Historic Building Looking East at the North Elevation.

Elevation descriptions: The west elevation of the building consists of a single wood door entryway on the lower level, a large rectangular casement window frame situated on the upper story, and a large outdoor light positioned near the top of the gable. There is an unusual metal

fascia placed on the board and batten siding next to the roofline of the gable and the remnants of fiberglass siding located on the south side of the west elevation. The north elevation is composed of one large rectangular fixed window positioned in the center of the elevation and is flanked on both sides by two double hung sash windows. All of the windows on the north elevation are boarded over and missing most or all of the glass. The east elevation consists of a brick and concrete block chimney. The original chimney was composed of brick and appears to have been enhanced or fortified with large concrete blocks. There is an addition to the chimney on this elevation with a covering made of a wood frame construction clad in board and batten siding with a small gabled roof. There is also a rectangular casement window positioned to the south of the chimney. The south elevations consist of a large rectangular fixed window and two rectangular double hung sash windows with a single wood door entryway positioned in between. Please note that the entryway appears to have been altered to fit a sliding glass door at one time and then converted back to fit the single door entry; one side of the opening is boarded over with a large piece of plywood.

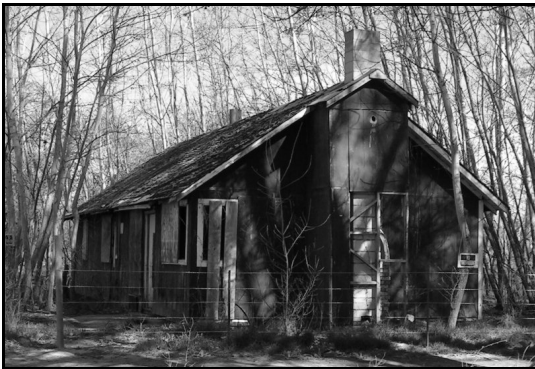
Historic Building Looking Northwest at the South and East Elevations.

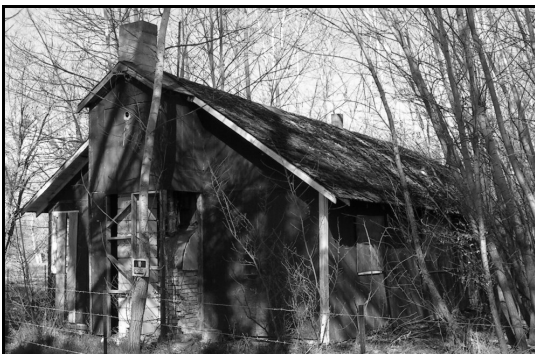
Historic Building Looking Southwest at the North and East Elevations.
