# PIONEER VILLAGE

MACK QUINNEY  
ARCH 4394  
FALL 85

## OUTLINE

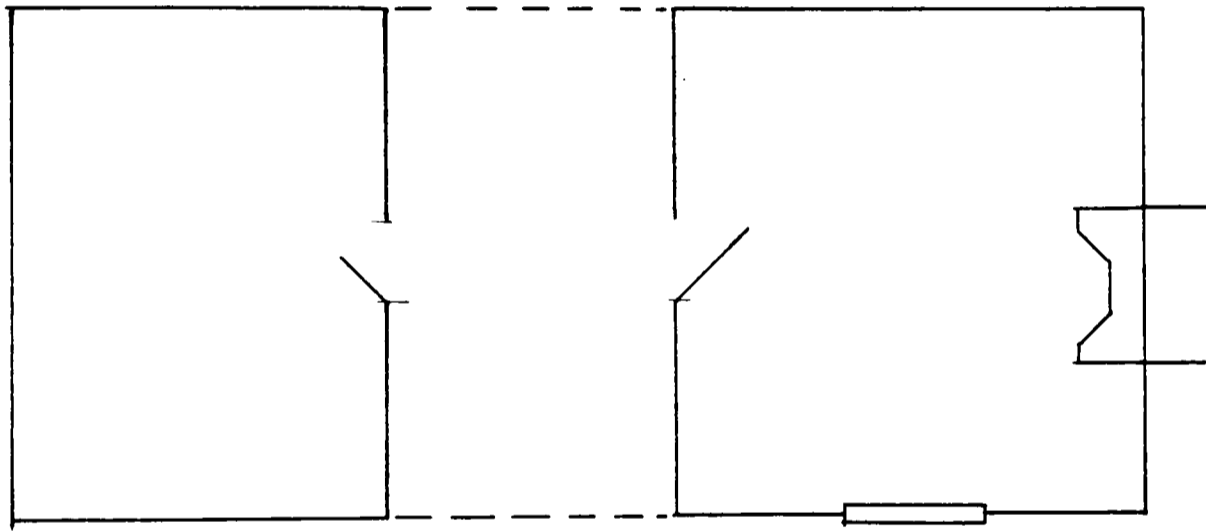
The Baker/Seiler house is located on the Claude Lee property in the Otto Von Roden Survey 3462, Gonzales County, Texas (six-tenths of a mile northwest of Cheapside). It is a log constructed building of the "dog-run, dog-trot" type with dimensions of forty-four by twenty-six feet, and was built in the late 1850's by Thomas Baker.

Thomas Baker purchased the property the cabin sits on in 1856 (confirmed by deed records in Gonzales court house). Later the house and property was bought by Mr. and Mrs. Fred Seiler. This house is thought to be the first house built in Gonzales County. At one time the house had two black servants. This would explain the addition of two rooms that were later added to the back of the house. The construction is of planked oak logs with a square notched joint.

this is not present now. The foundation is of regularly spaced granite blocks acting as footings for the logs.

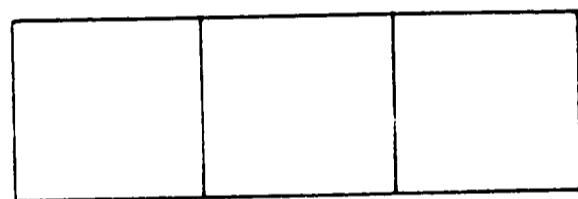
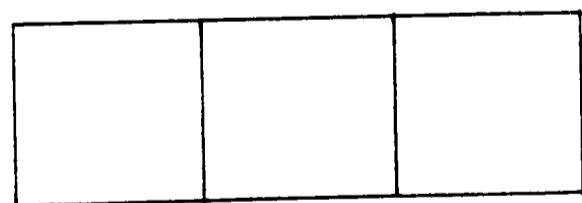
Original Layout of the Six Buildings

The building was ordinarily part of six buildings that were a library stop in Belmont. This is the only building of the original six that still stands. At one time it was used as a blacksmith shop, but more recently it was used to store grain to feed the horses located there.

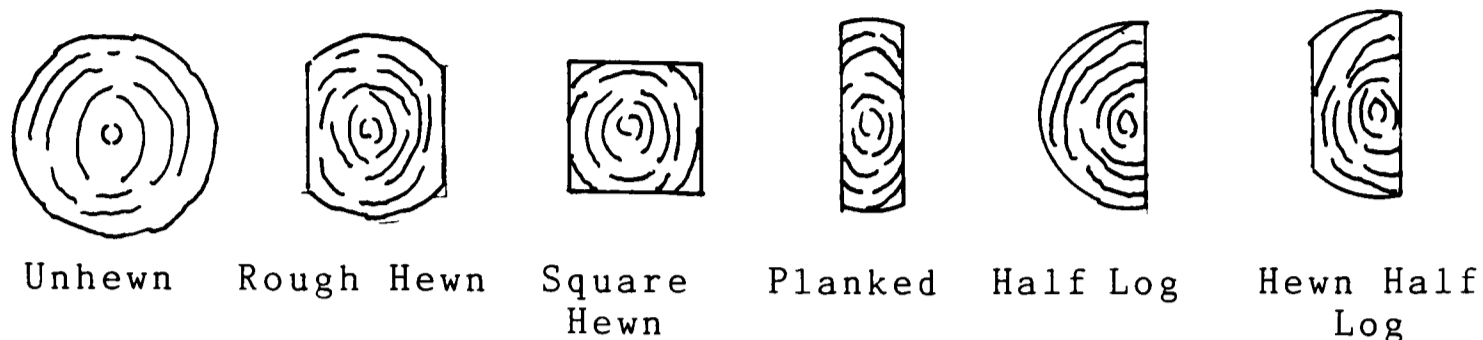
The foundation is usually set on two foot piers sticking out of the ground, or flat stones (usually sand stone), which are placed at the four corners, and intermediate points as required. Next the logs for the foundation are cut. (Type of wood varies according to location.) They are then brought to the site and prepared for the cabin. Preparation begins by hewing. Hewing is accomplished by scoring with a broad axe, then chalking a line and taking a foot axe and cutting,

or hewing, to that line. A plank cut is the most common, but other methods exist including: unhewn, rough hewn, square

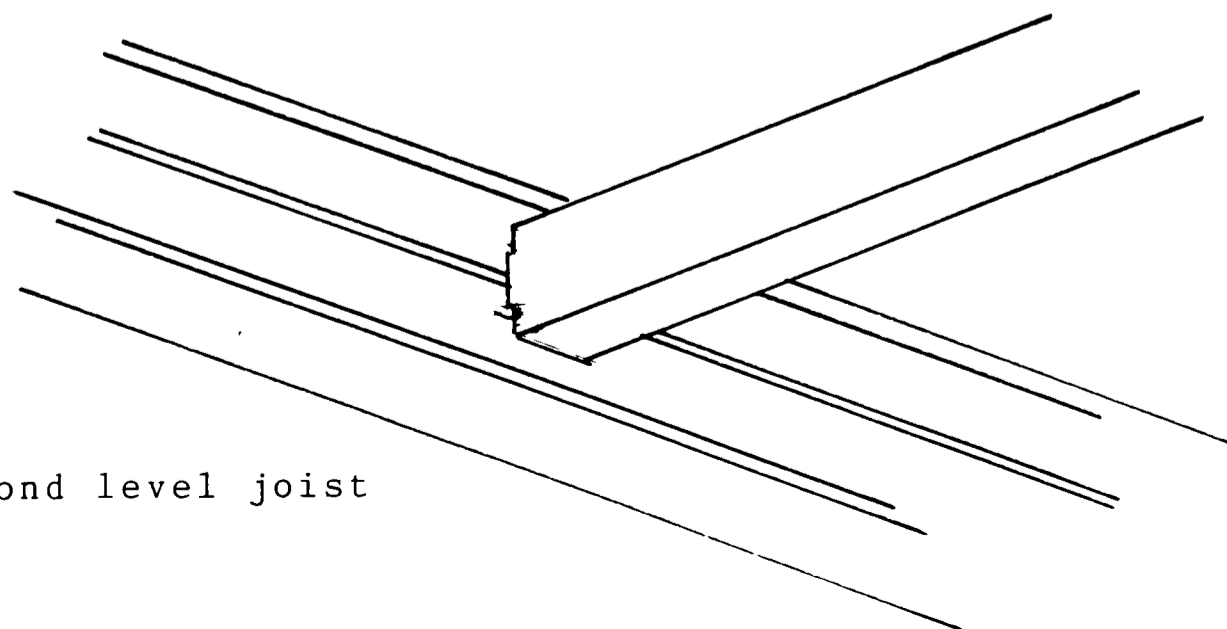
Morticed second level joist

If the structure is to have a loft, logs in the wall, at the desired height, are morticed so as to put in the joists for the upper level. Some of these joists are hewn in a square hewn pattern, and placed at two foot intervals.

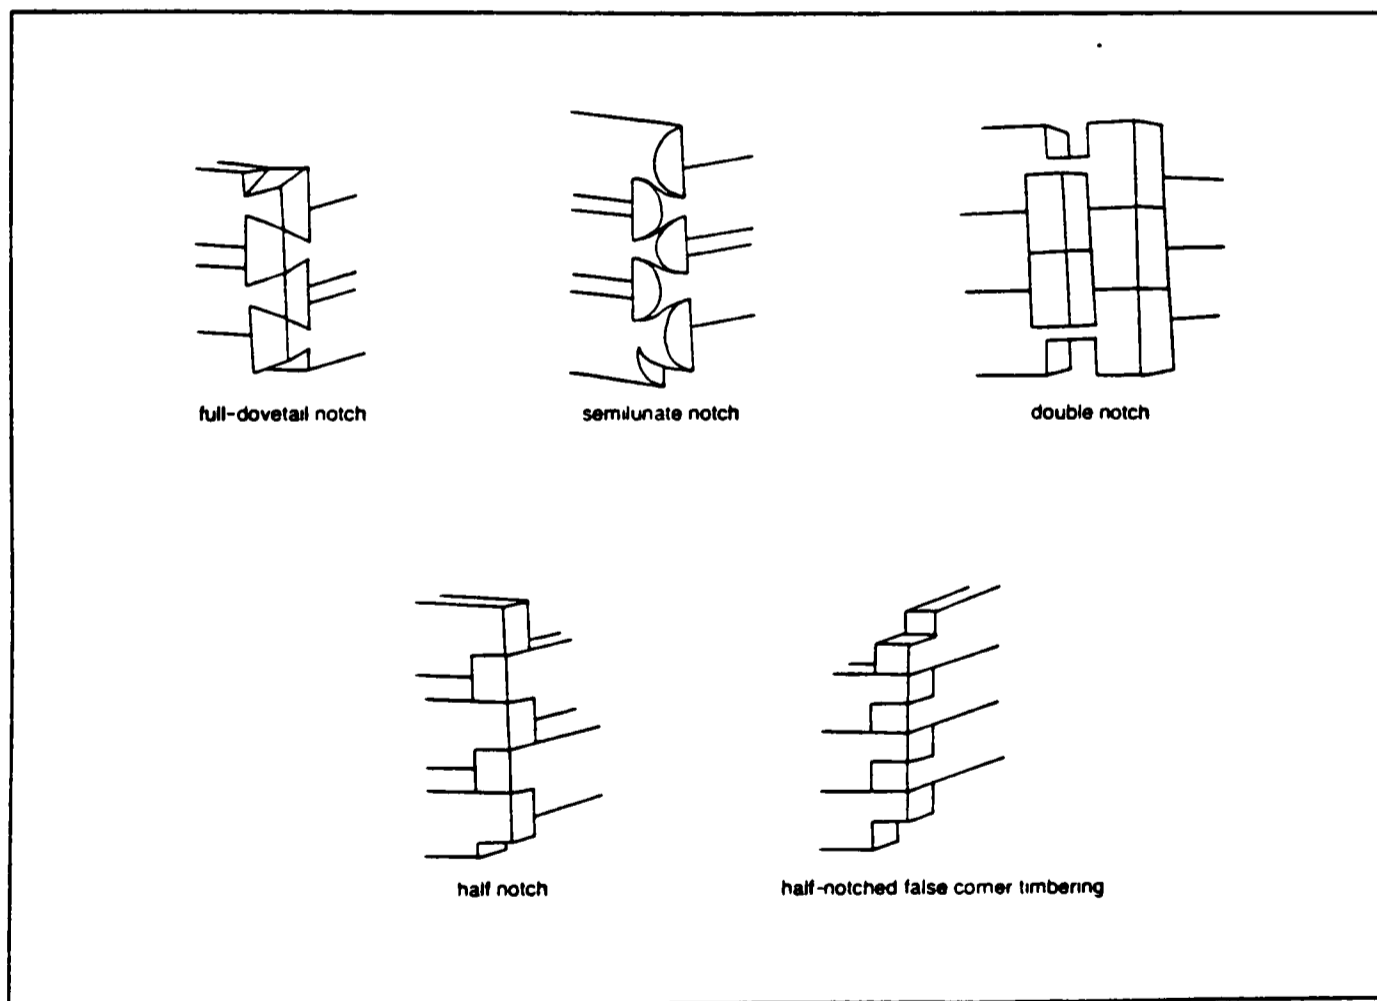
Minor Notch Types

Notching is done with a broad axe and a saw. This part of making the structure takes the most skill by the carpenter.

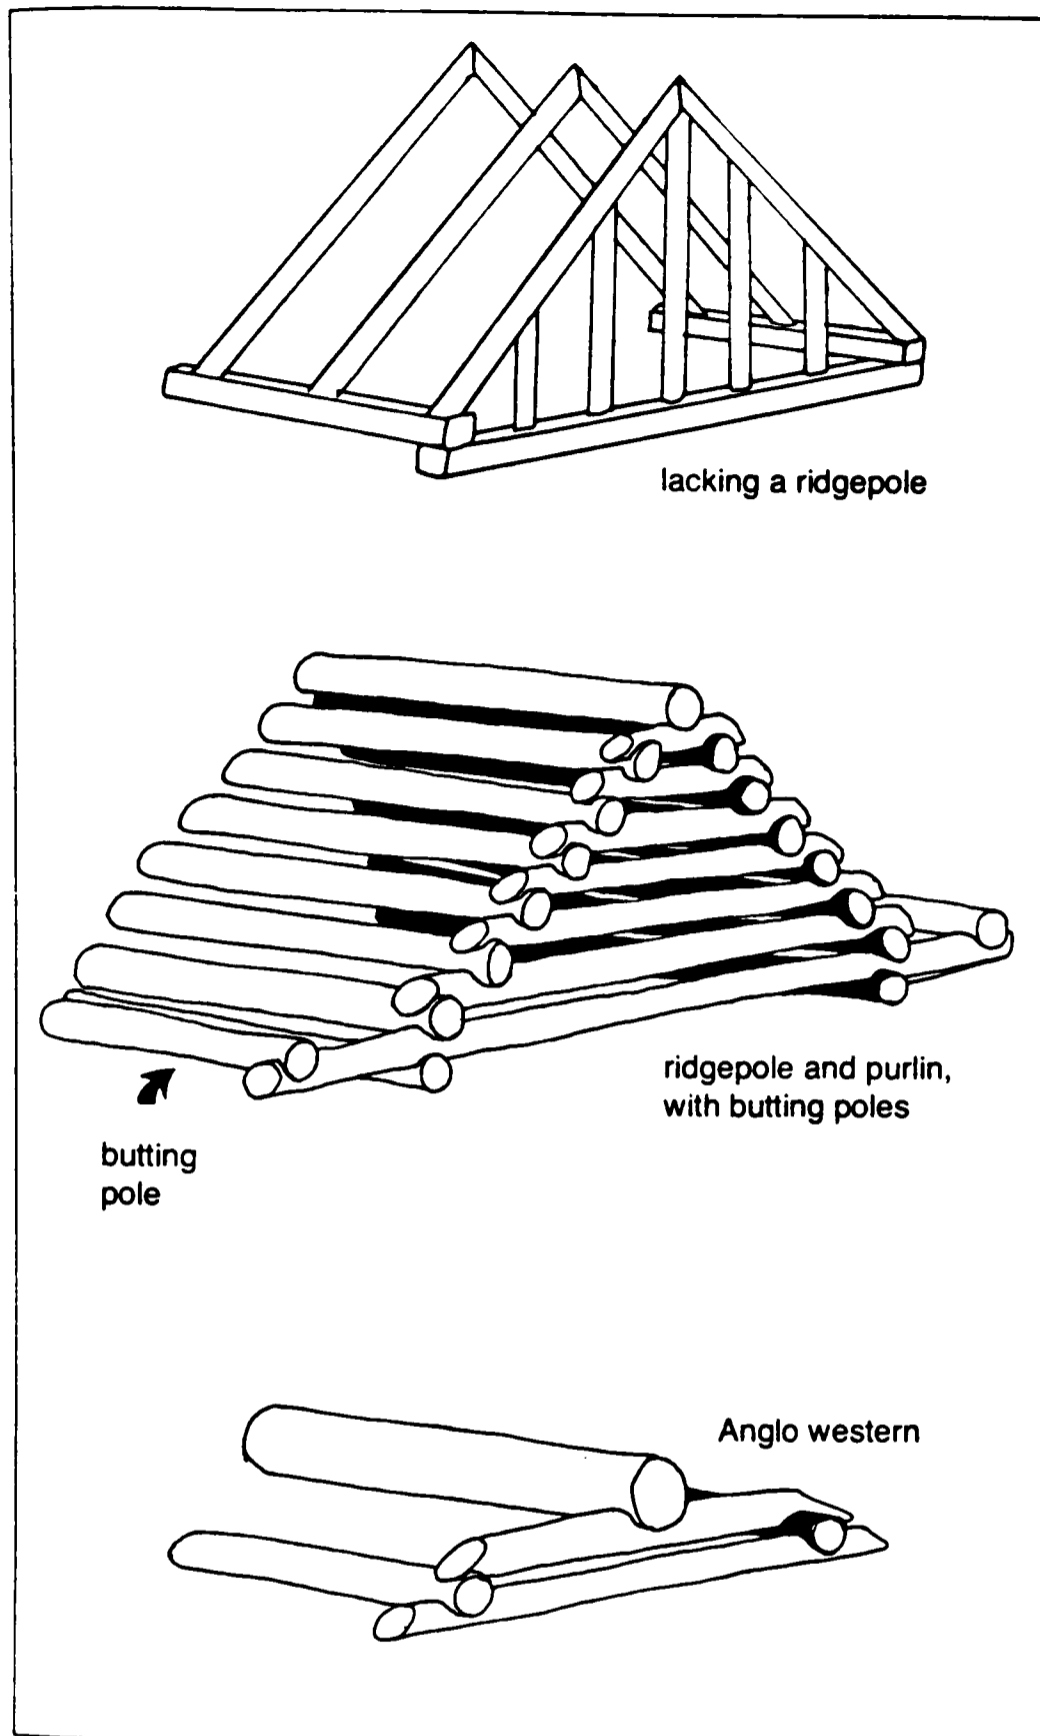
### Roof Structure Types

There are three major roof types in log structures. The first being the most common is the gabled roof. This roof lacked a ridge pole and had rafters made of small logs. The rafters are lap jointed or morticed together at the ridge, and are secured with a wooden pin. Sometimes long laths are placed at the corner base and run diagonally to the opposite gable peak to give extra stability. Also to add stability, the gabled ends were studded up running the length of the gable. The second type of roof was the ridgepole and purline. This roof is constructed by continuing the logs up at an angle with the top log being called a ridgepole. The third and final roof structure is the Anglo western. This consists of stacking one log in, placing another log at the gabled end, and then putting a ridgepole down the center.

After the roof structure is built then the covering is applied. There are several ways of doing this also. The first is the use of boards or clapboards, especially with the ridgepole and purlin type of roof. These boards were held in place by "butting" poles which were layed vertically to the

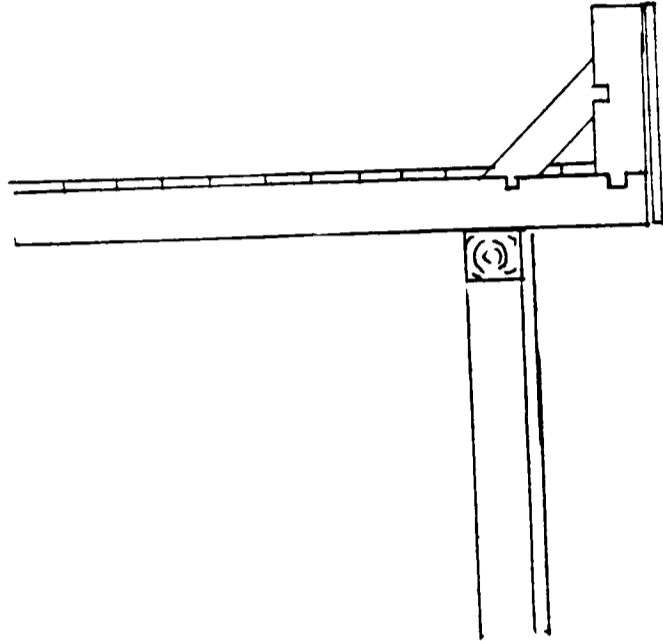
The fort was constructed in a square at thirty foot on all sides, with an oak half timber frame and six inch pine planks hung vertically on the exterior. The roof of the structure was flat, forming a desk and platform which projected out beyond the walls.

This afforded protection from all sides, and also formed a cannon platform in which to defend attacks from the sea.

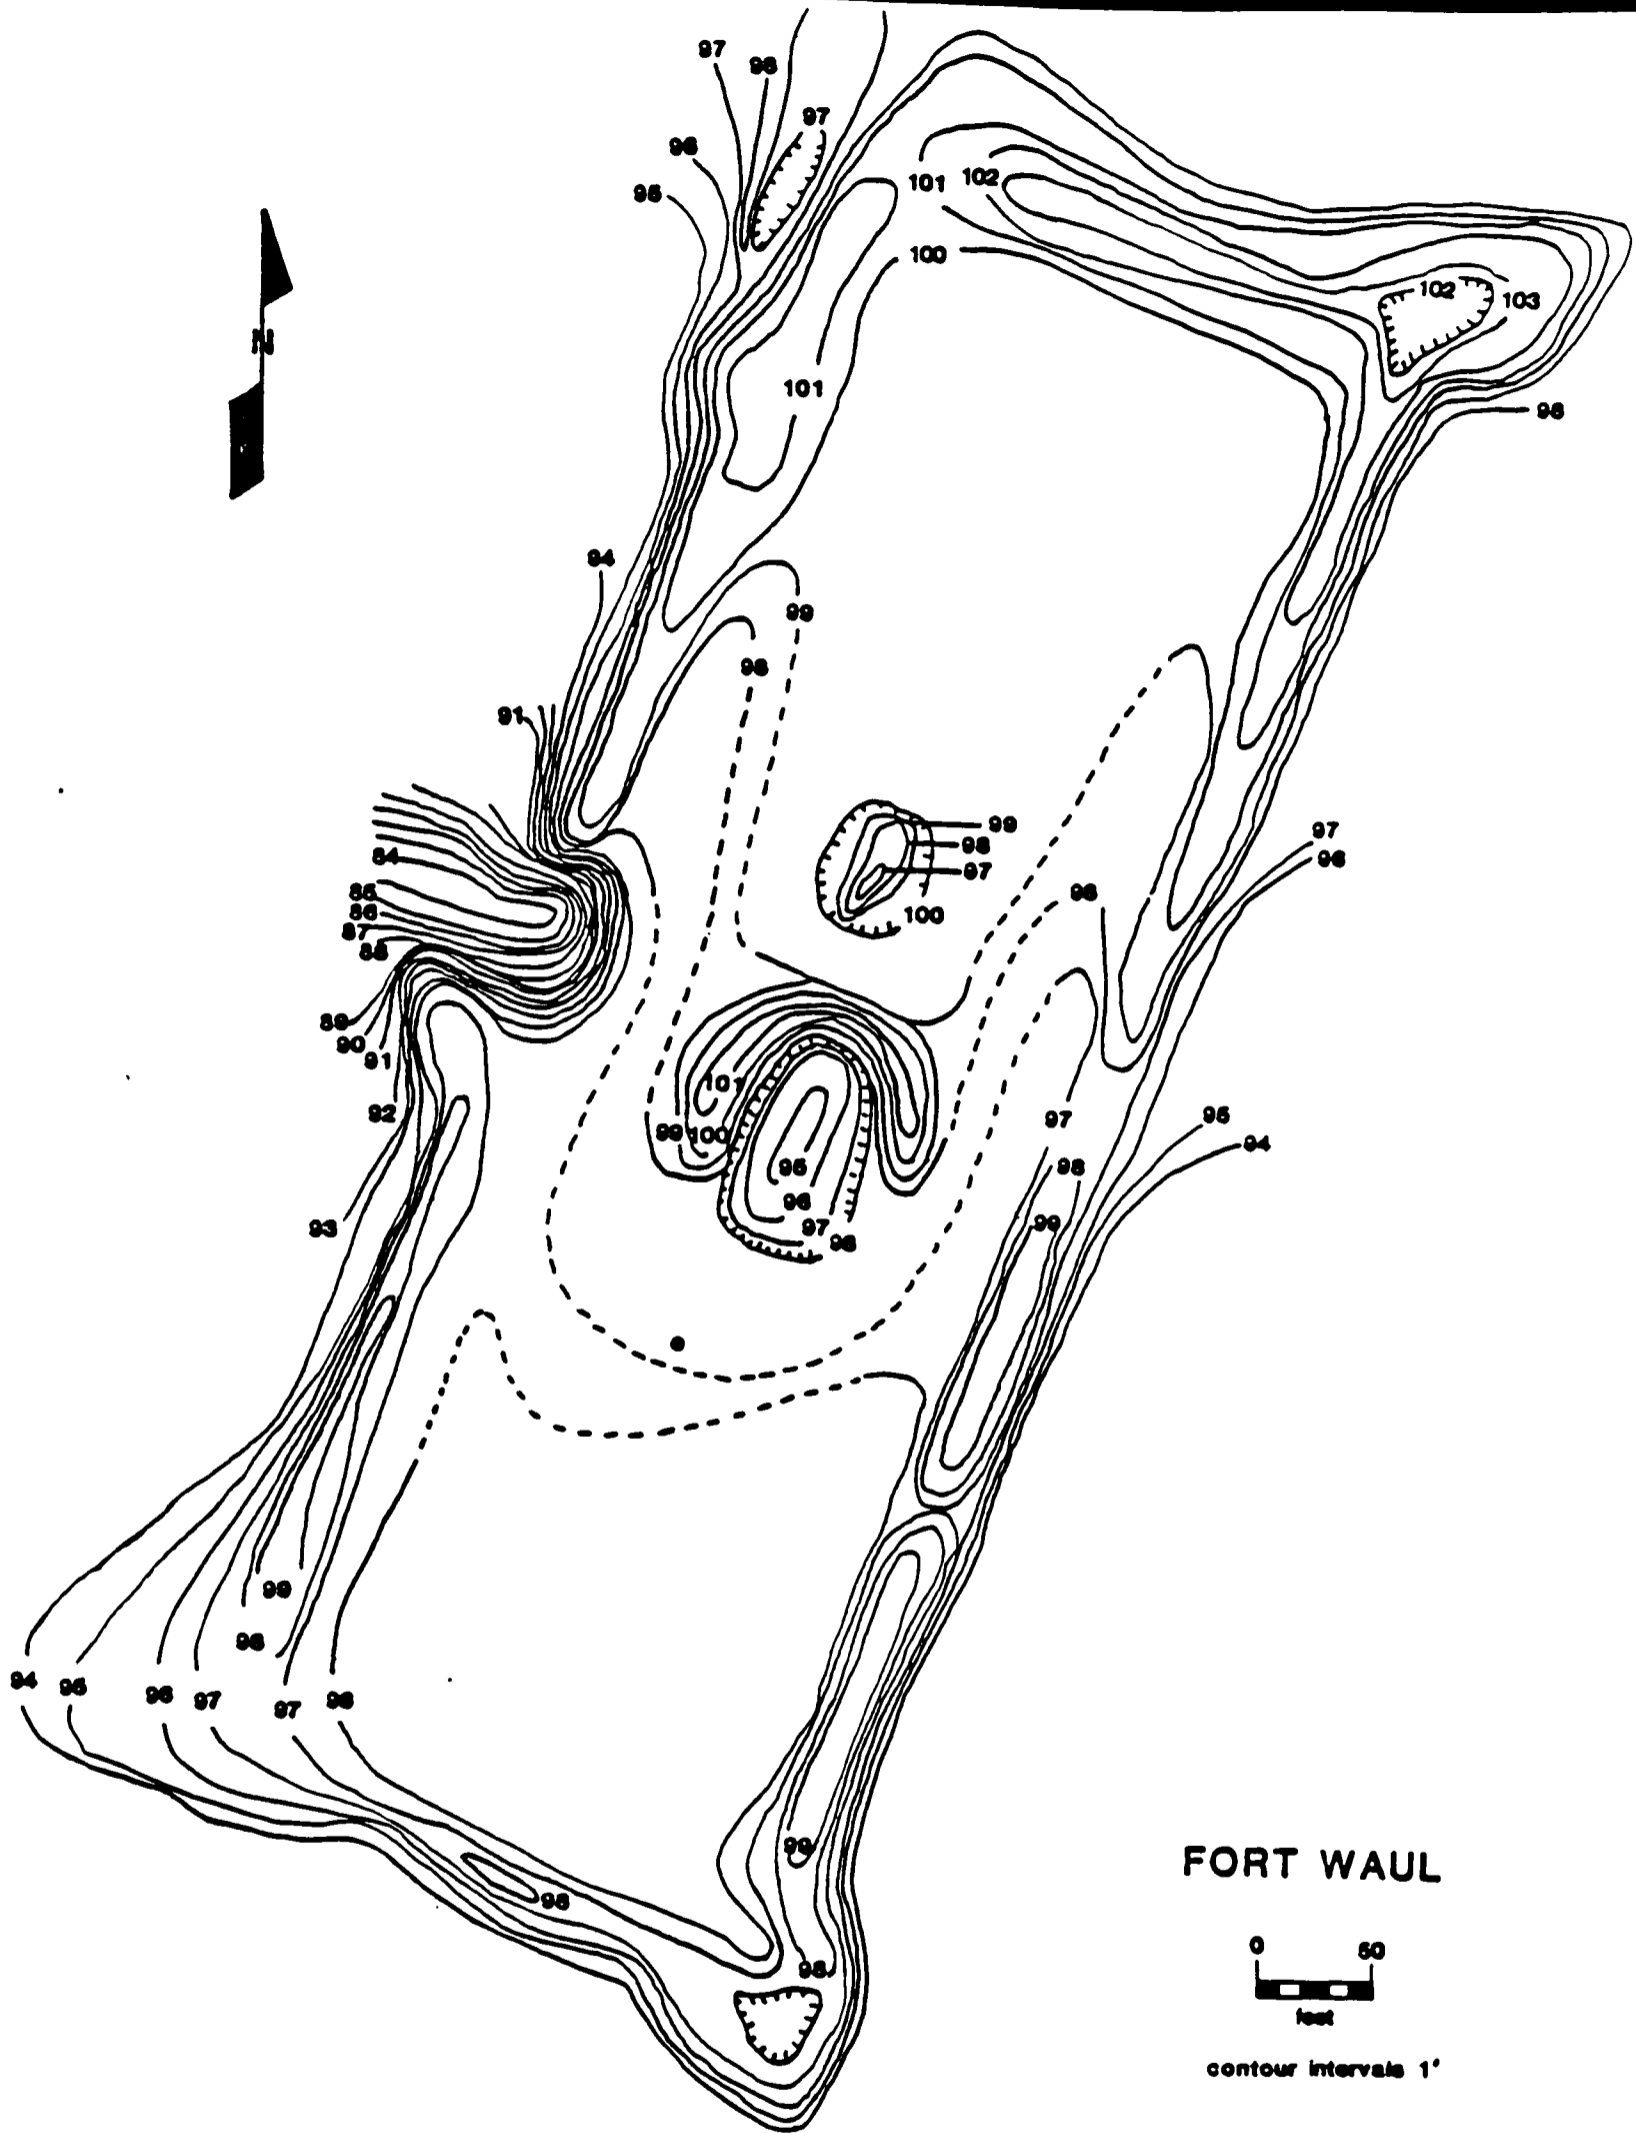
Figure 3. Plan map of Fort Waul, C.S.A. showing earthworks and other extant features. Map prepared by Southwest Engineers, Inc., Gonzales, Texas.

At present, the physical features which best describe Fort Waul are the earthworks in which there are bastions in the southeast and northeast corners, a salient angle (redan) in the center of the western wall, a major depression near the center of the enclosure created by the earthworks and a smaller depression just to the north. These are illustrated in Figure 3. The following discussion presents a summary of each of these features and relates the present condition to the description of the Fort as taken from the previous chapter.

The interior of the earthworks, that is from the base of the earthworks to the base of the earthworks on the opposite wall, is an area that is approximately 225 ft by 725 ft. This compares favorably to the 250 by 750 ft size noted on the Wickland map. If measured from the crest of one wall to the opposite wall, this is an area approximately 250 by 750 ft. The walls range from 25 to about 35 ft wide at the base, but this dimension is probably exaggerated by the erosion that has occurred since construction. Wall height ranges from four to five ft but is shorter inside the Fort than outside where the presence of the ditch accentuates the wall height. Walls are less steep on the inside of the Fort and also narrower when measured horizontally from the crest of the wall to the base of the wall. In contrast, the

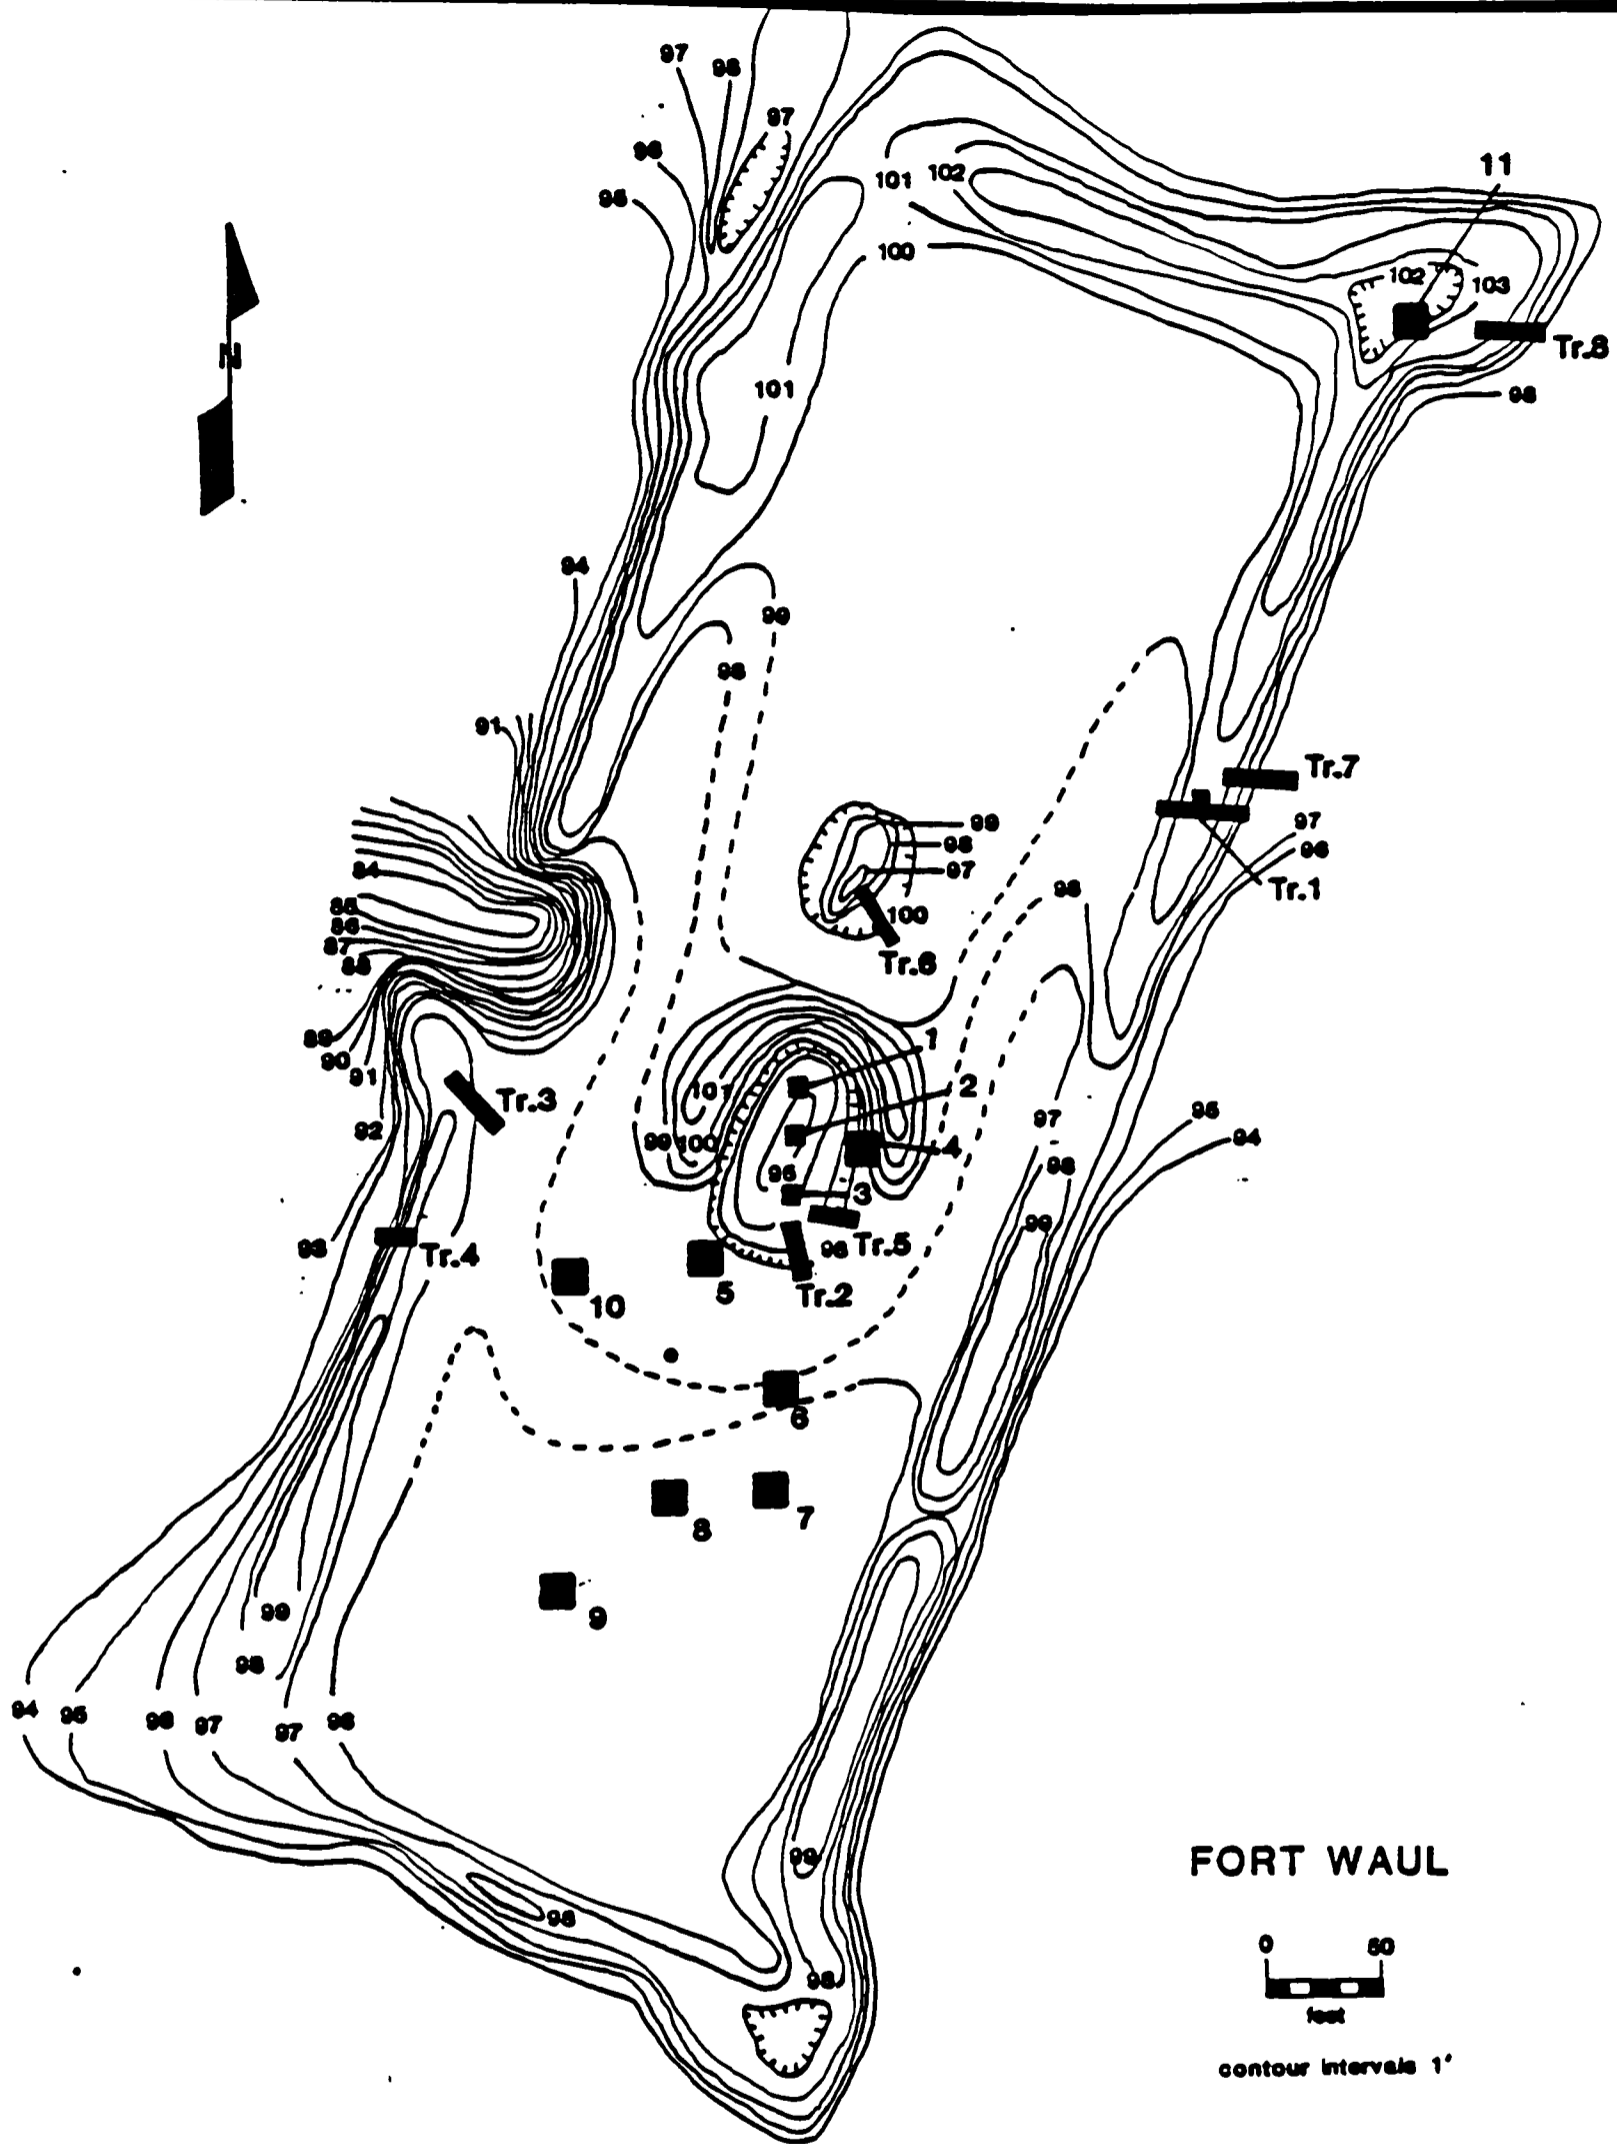
7 **Figure 4.** Plan map of Fort Waul, C. S. A. showing the location of excavation units in relation to earthworks and other features. Unit sizes has been exaggerated for emphasis.

The following section presents the description of each of the excavation units that were cleared during the 1983 investigations at Fort Waul. Excavations were conducted inside the blockhouse and the northeast bastion using test pits and in the parade ground south of the blockhouse (Figure 4). Hand-excavated trenches were dug in the eastern earthworks and in the area of the salient angle (redan) on the west earthworks. Ultimately, backhoe trenches were dug in the blockhouse, in the depression to the north of the blockhouse and in the bastion and the eastern earthworks. Each unit is described below. Where appropriate, illustrations are used to provide a more complete description of the unit or its stratigraphy. A total of 11 test pits were cleared and are described first. This is followed by the four hand dug trenches and the four backhoe dug trenches.

This hand-dug trench was excavated to expose the profile of the eastern earthworks and the scarp and counterscarp. The trench is located north of where the salient angle (redan) in this wall must have been (see Figure 4). The trench was

A trench was excavated by hand in the southeast corner of the blockhouse depression for the purpose of locating the wall line (see Figure 4). The trench was approximately 7.5 m in length and one meter wide. It was 40-50 cm deep in most areas but was extended to one m when the wall was thought to have been located.

This hand-dug trench was placed in the area of the salient angle in the western wall (Figure 4) for the purpose of isolating the original ground surface and recovering datable artifacts. The trench was nine m long and 1.1 m wide and was excavated to 50 cm in most areas. No artifacts were recovered in any of the ten cm levels although the fill was not screened because of the tight soil that was present. A

This hand-dug trench was placed from the top to the outer limit of the earthworks south of the redan in the western wall (see Figure 4). The trench was 4.5 m by 1 m and was dug to a maximum of 45 cm. The fill throughout was a dense, very dark gray (7.5YR3/0) clay that yielded no artifacts. There were only occasional gravels in the trench fill.

This trench, located in the eastern wall of the blockhouse depression, was dug with a backhoe (see Figure 4). It was 6.8 m in length and extended just over one meter in depth. Five strata were exposed, and the probable edge of the blockhouse wall was also encountered (Figure 9). Zone A is a humus layer that is 10-15 cm thick and is a dark brown (7.5YR3/2) color. Zone B is a sandy clay that is dark brown (7.5YR3/2). Zone C occurs in two areas; one is in the floor of the blockhouse. The second, to the east, is truncated at this location. This appears to correlate with the line noted in Trench 2 and marks the edge of the depression dug to form the blockhouse wall. Zone C is white in color (7.5YR8/0 with 7/2 and 6/8 mottles). Zone D occurs only in the blockhouse and is a pale olive (5YR6/3) clay. Five square cut nails, a fragment of a can rim and a piece of brown bottle glass were recovered from the fill of this trench. The glass appears recent, but the nails could date to the time of the Fort. Zone E underlies Zone B outside the wall line and is a dark brown (7.5YR3/2) sandy clay that contains an abundance of gravel.

This trench was excavated with the backhoe and was 8.5 m long. The purpose of the trench was to determine the nature of the depression that is located north of the blockhouse depression (see Figure 4). Four zones were exposed, and only one (D) showed any unconformity (Figure 10). Zone A is a loose, dark brown (7.5YR3/2) sandy clay loam. This rests on Zone B which is a mottled caliche that is white (7.5YR8/0) with strong brown (7.5YR5/8) mottles. On the eastern end of Zone B, it

This trench was placed just north of Trench 1 for the purpose of exploring the profile of the scarp and counterscarp outside the eastern wall of the earthworks (Figure 4). The trench was just over 12 m long and was dug with a backhoe. The results of the trench are similar to those of Trench 1. Zone A is the top of the earthworks and is truncated on the outside of the earthworks (Figure 11). It is light yellowish-brown (10YR6/4) in color and is a sandy clay. Zone B underlies A and has eroded into the ditch depression. This is a dark brown (7.5YR3/2) sandy clay. This may be its original geological position. Zone C is a sandy clay with gravel and is also dark brown in color.

This 8.3 m long backhoe trench was dug in the wall of the northeast bastion (see Figure 4). Four zones were uncovered in the north wall of the trench (Figure 12). Zone A is a very gravelly, sandy clay matrix which is dark brown (7.5YR3/2) in color. This was the fill used to construct the earthworks. However, since construction abandonment has eroded and covered the fill of the scarp and counterscarp. No visual break could be made between the slope of the earthworks and the fill which has eroded and covered Zone B. Zone B is an ashy layer that was in the ditch. The zone is white (2.5Y8/0) in color. The lowest zone (C) is a light yellowish-brown (10YR6/4) clay that underlies most of the northern half of the fort area. A small intrusion was recorded as Zone D. This zone is a strong brown (7.5YR4/6) color.

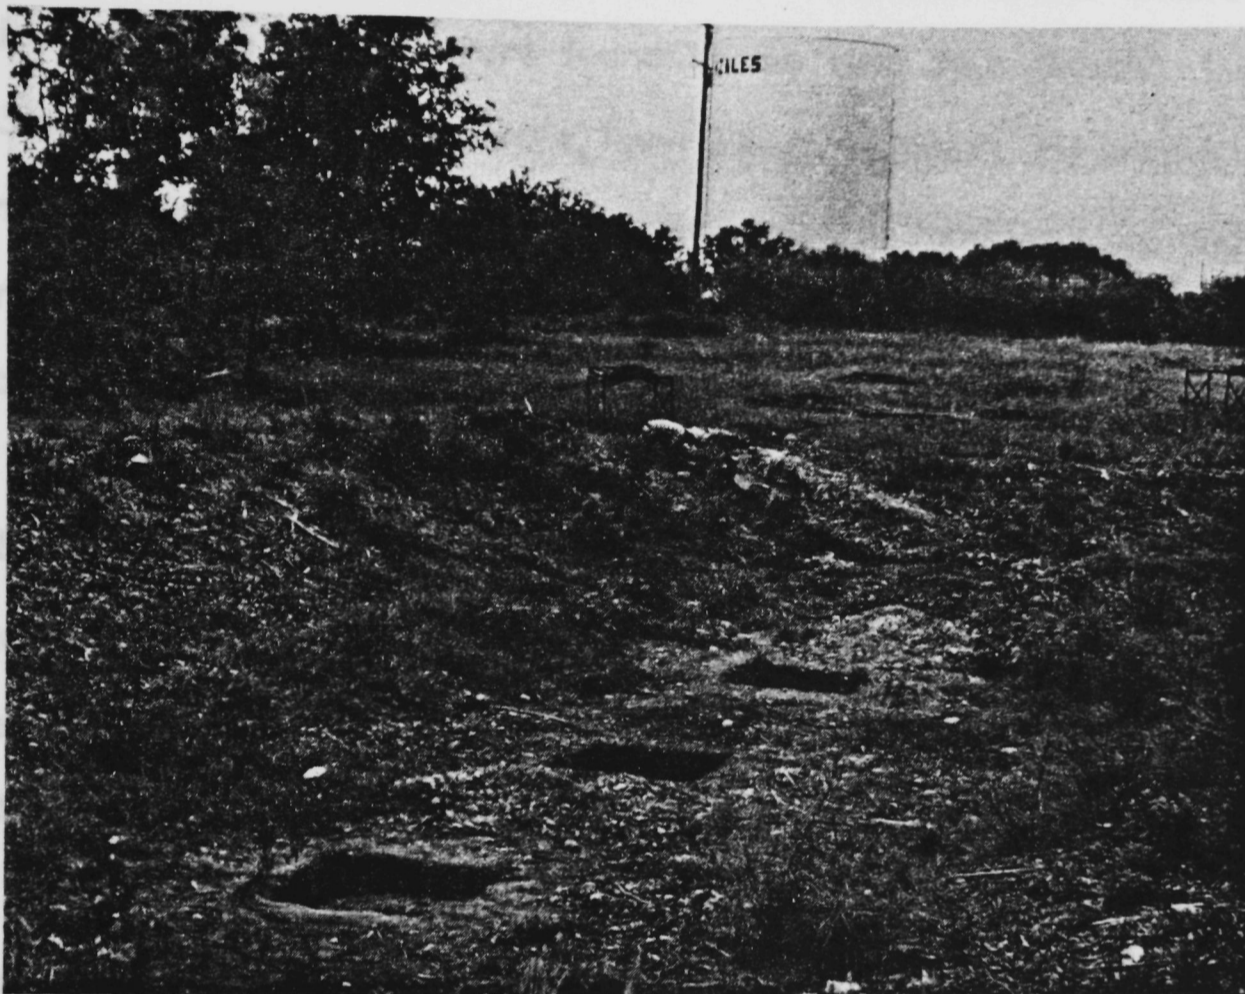
Figure 5. Overall view of excavation in the blockhouse depression. View is to the southeast.

This 1 x 1 m square was excavated to a maximum depth of 30 cm. The unit is located in the north-central part of the blockhouse depression (Figure 5). Numerous Eocene gravels were found in the second and third levels. Many small rusted pieces of metal (including two can rim fragments) were in the first level. Nothing was in the second level, but a large square cut nail fragment and a heavily rusted can rim(?) were in level 3. Digging was discontinued at the base of level 3 due to the low artifact yield and the presence of apparently in situ gravels.

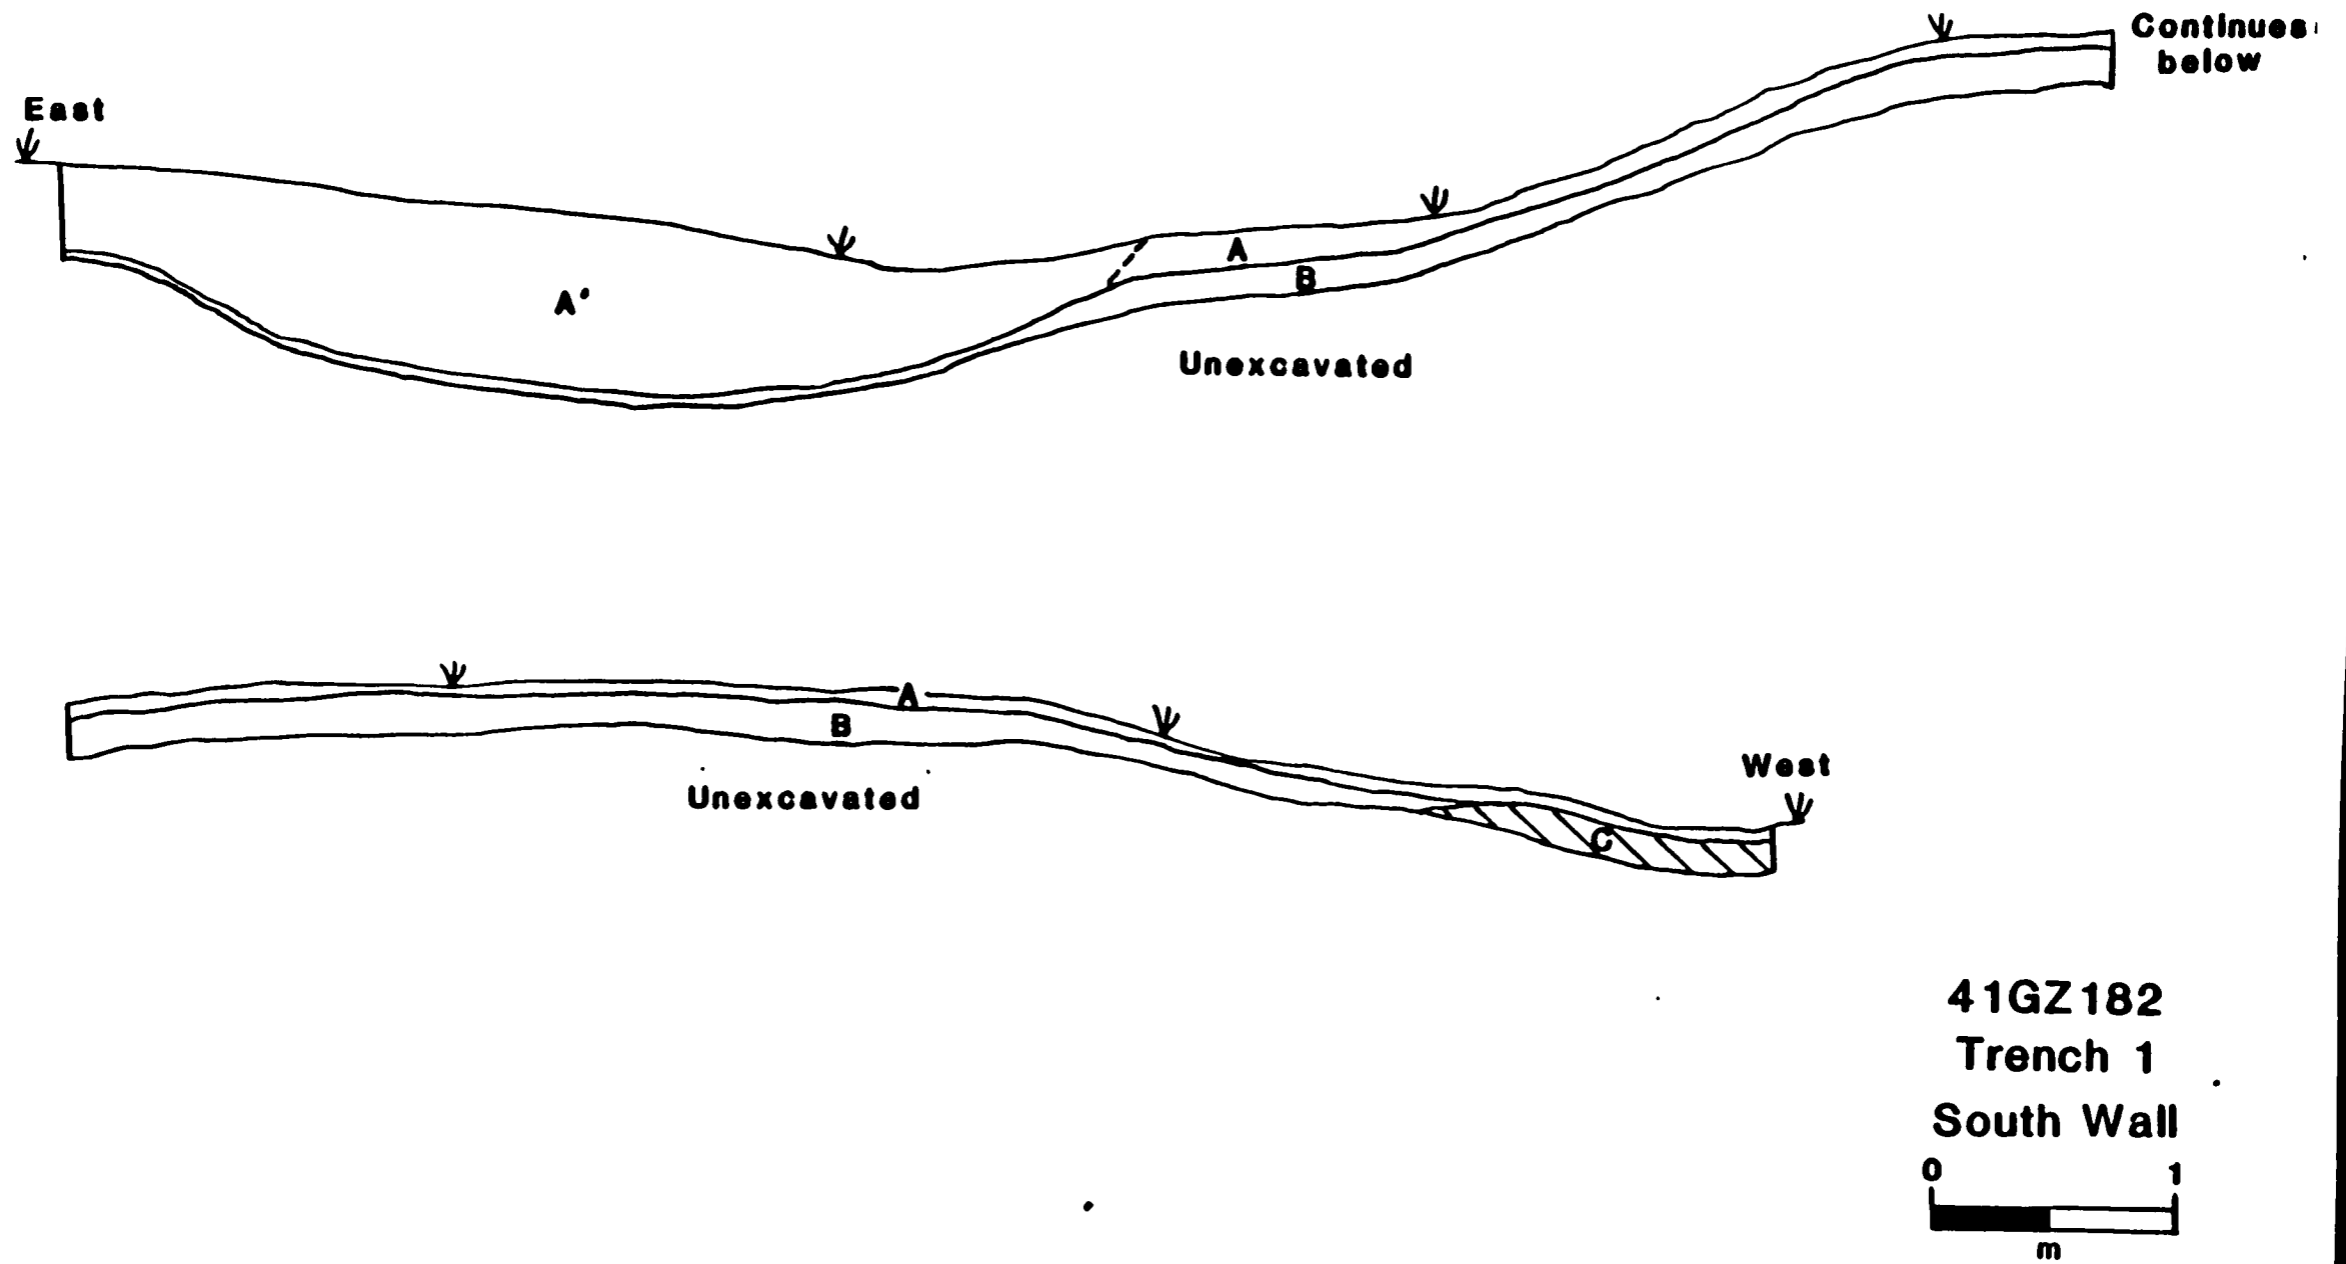
Figure 6. Profile of the south wall of Trench 1.

15.5 m in length and approximately one meter wide. The trench ranged in depth from approximately 25 to 75 cm depending upon the thickness of the buried strata and the configuration of the constructed features. Four strata or zones were uncovered (Figure 6). Zone A is a loose light yellowish-brown (10YR6/4) topsoil that contained gravel and is 10-15 cm thick. It occurs as the top stratum over the earthworks. Zone A' is contiguous with A on the east end of the trench and represents the fill of the ditch. This stratum is from 15 to 65 cm thick and is a loose grayish-brown sediment. Many recent historic artifacts were recovered from this zone. Zone B is a dark brown clay. This stratum is very compact and contains very little gravel. This stratum underlies Zones A and A', and its thickness is not known because excavation was carried no further. It is truncated on the western end of the trench by Zone C which is a grayish-brown sandy clay that may be the original Fort surface. This stratum is at least 20 cm thick.
