# PIONEER VILLAGE

MACK QUINNEY  
ARCH 4394  
FALL 85

## OUTLINE

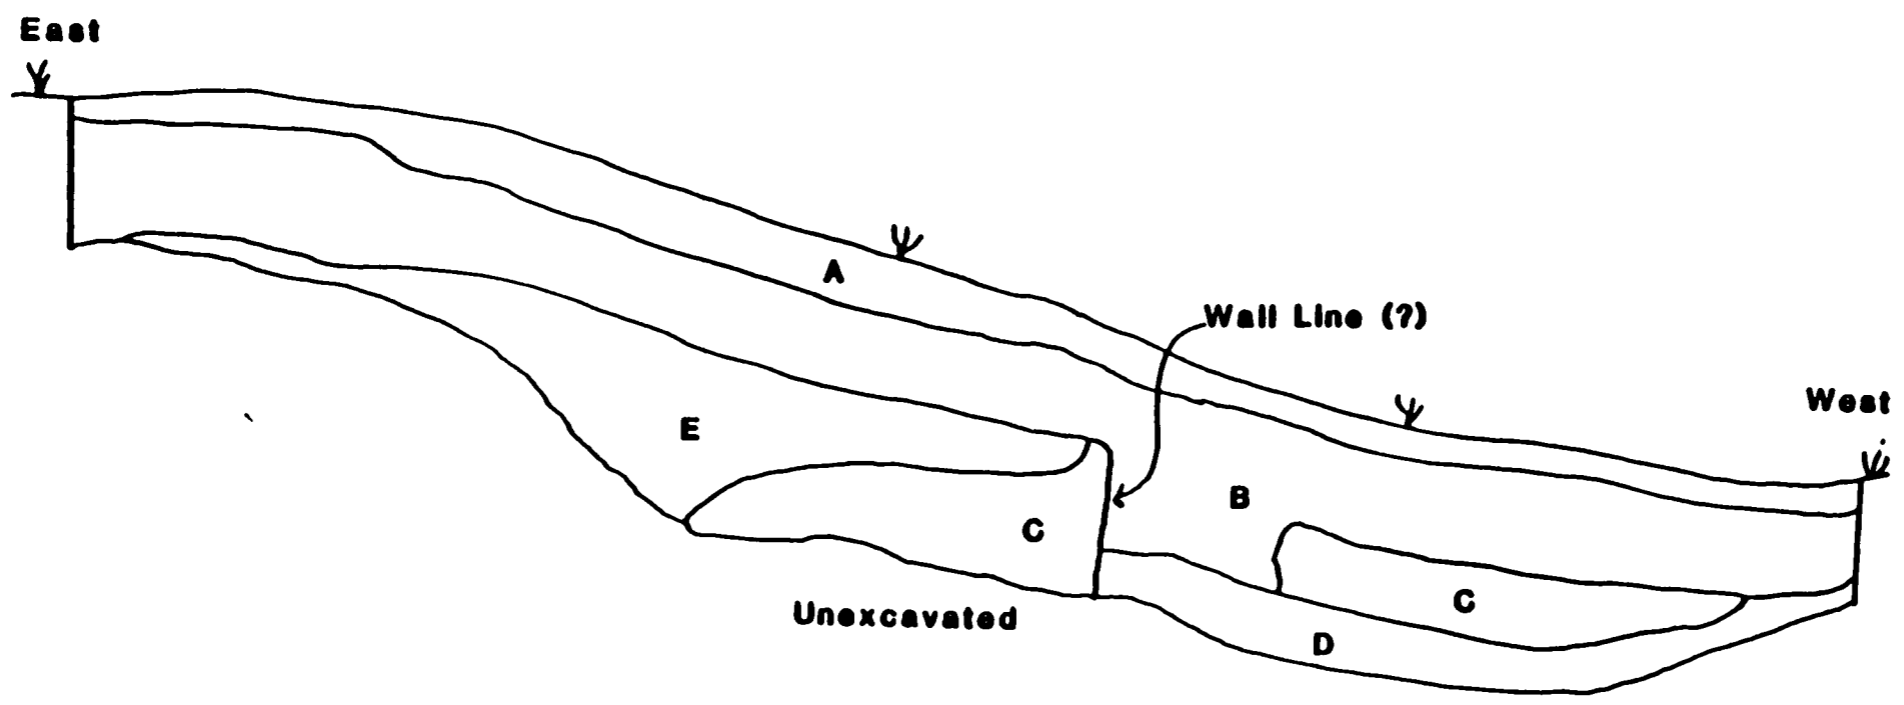
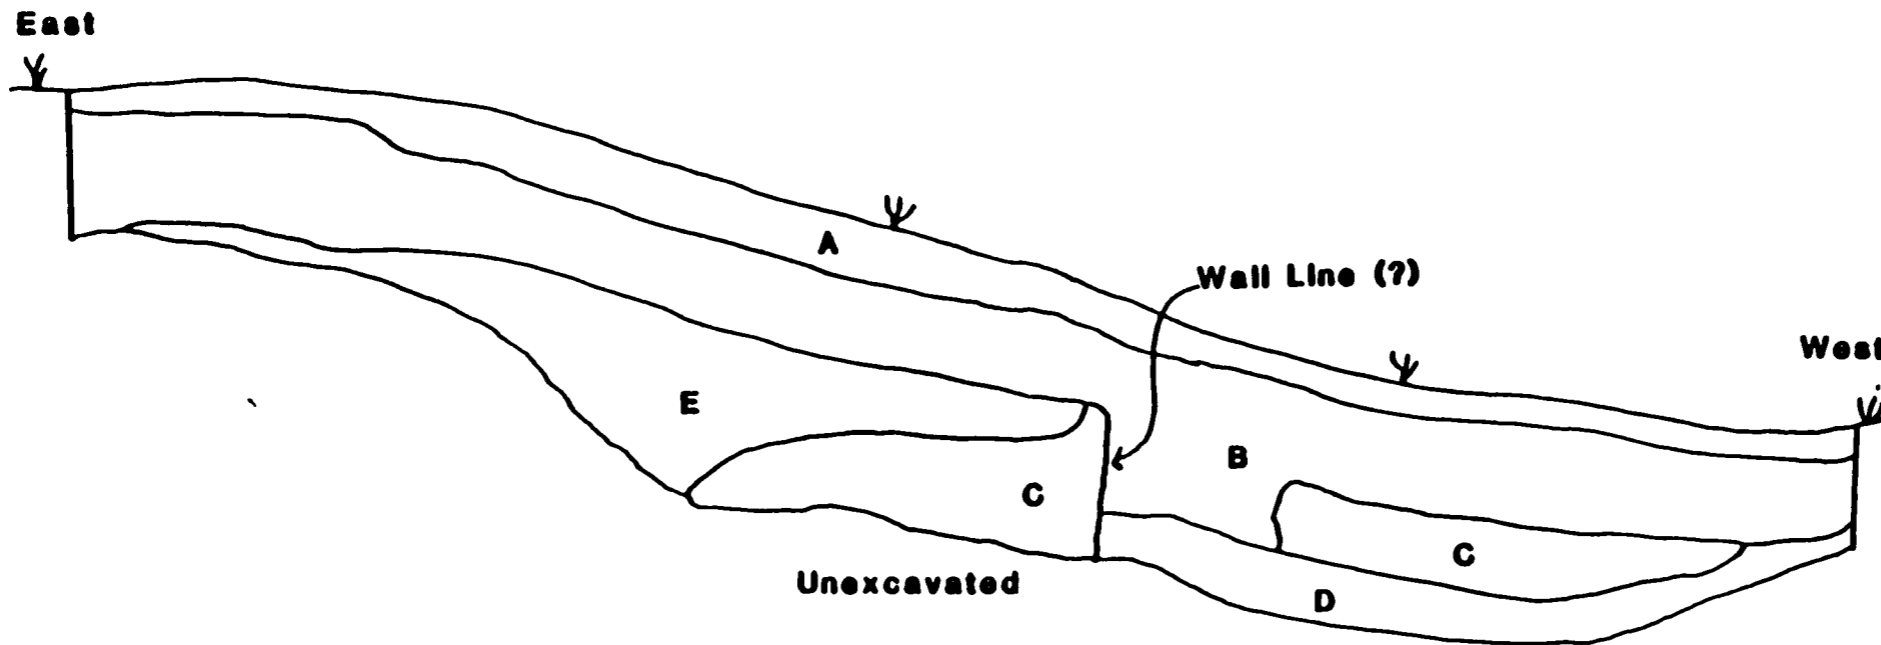
41GZ182  
Trench 5  
South Wall

Figure 9. Profile of the south wall of Trench 5.

This trench, located in the eastern wall of the blockhouse depression, was dug with a backhoe (see Figure 4). It was 6.8 m in length and extended just over one meter in depth. Five strata were exposed, and the probable edge of the blockhouse wall was also encountered (Figure 9). Zone A is a humus layer that is 10-15 cm thick and is a dark brown (7.5YR3/2) color. Zone B is a sandy clay that is dark brown (7.5YR3/2). Zone C occurs in two areas; one is in the floor of the blockhouse. The second, to the east, is truncated at this location. This appears to correlate with the line noted in Trench 2 and marks the edge of the depression dug to form the blockhouse wall. Zone C is white in color (7.5YR8/0 with 7/2 and 6/8 mottles). Zone D occurs only in the blockhouse and is a pale olive (5YR6/3) clay. Five square cut nails, a fragment of a can rim and a piece of brown bottle glass were recovered from the fill of this trench. The glass appears recent, but the nails could date to the time of the Fort. Zone E underlies Zone B outside the wall line and is a dark brown (7.5YR3/2) sandy clay that contains an abundance of gravel.

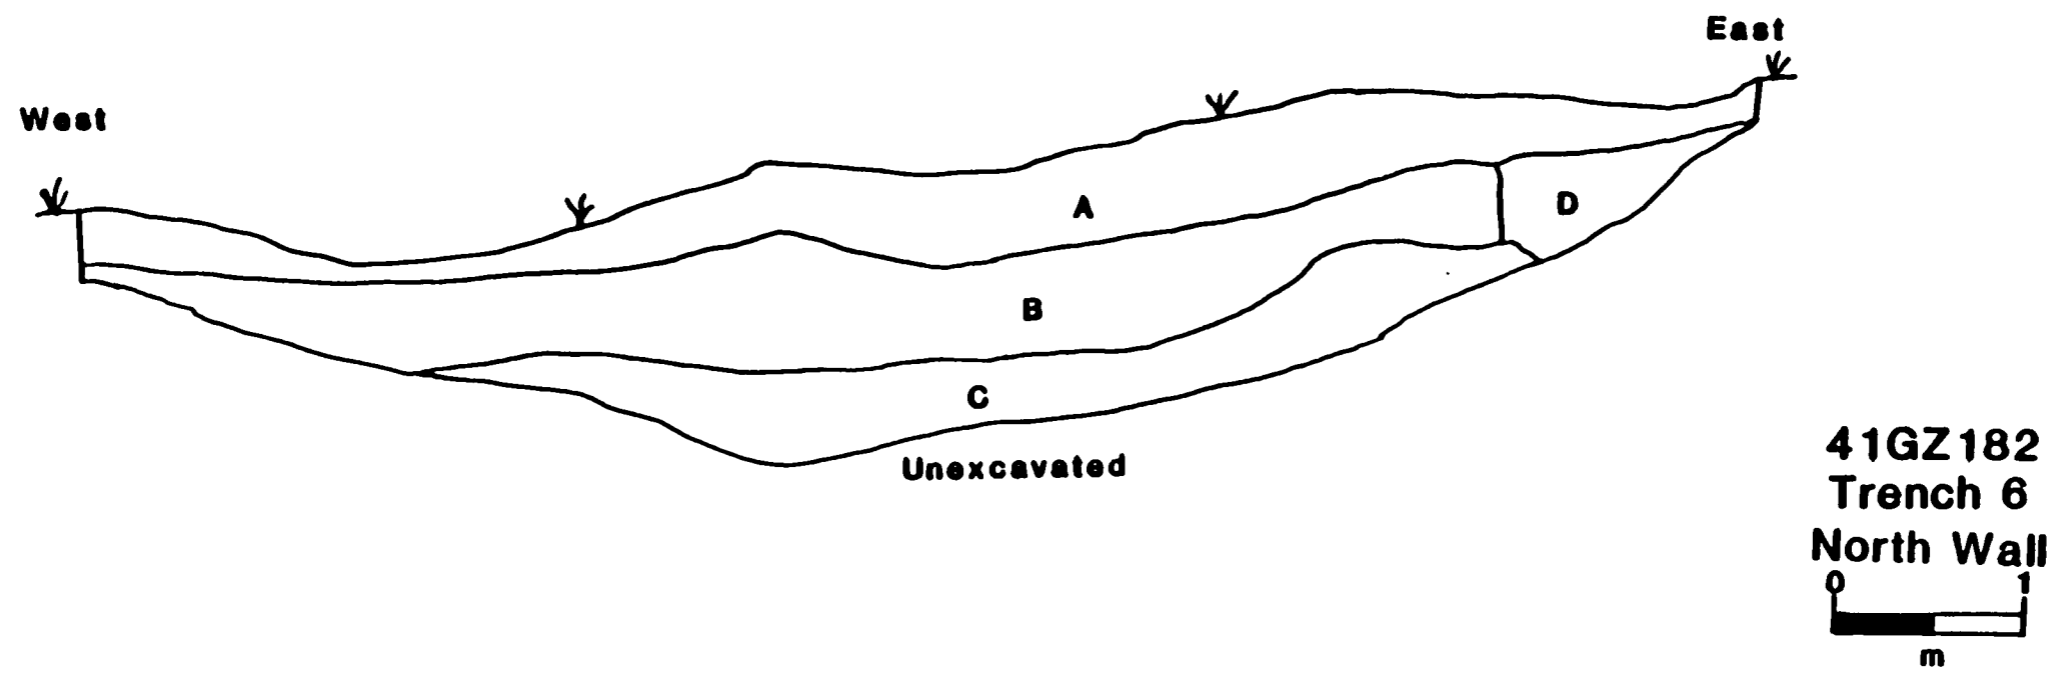
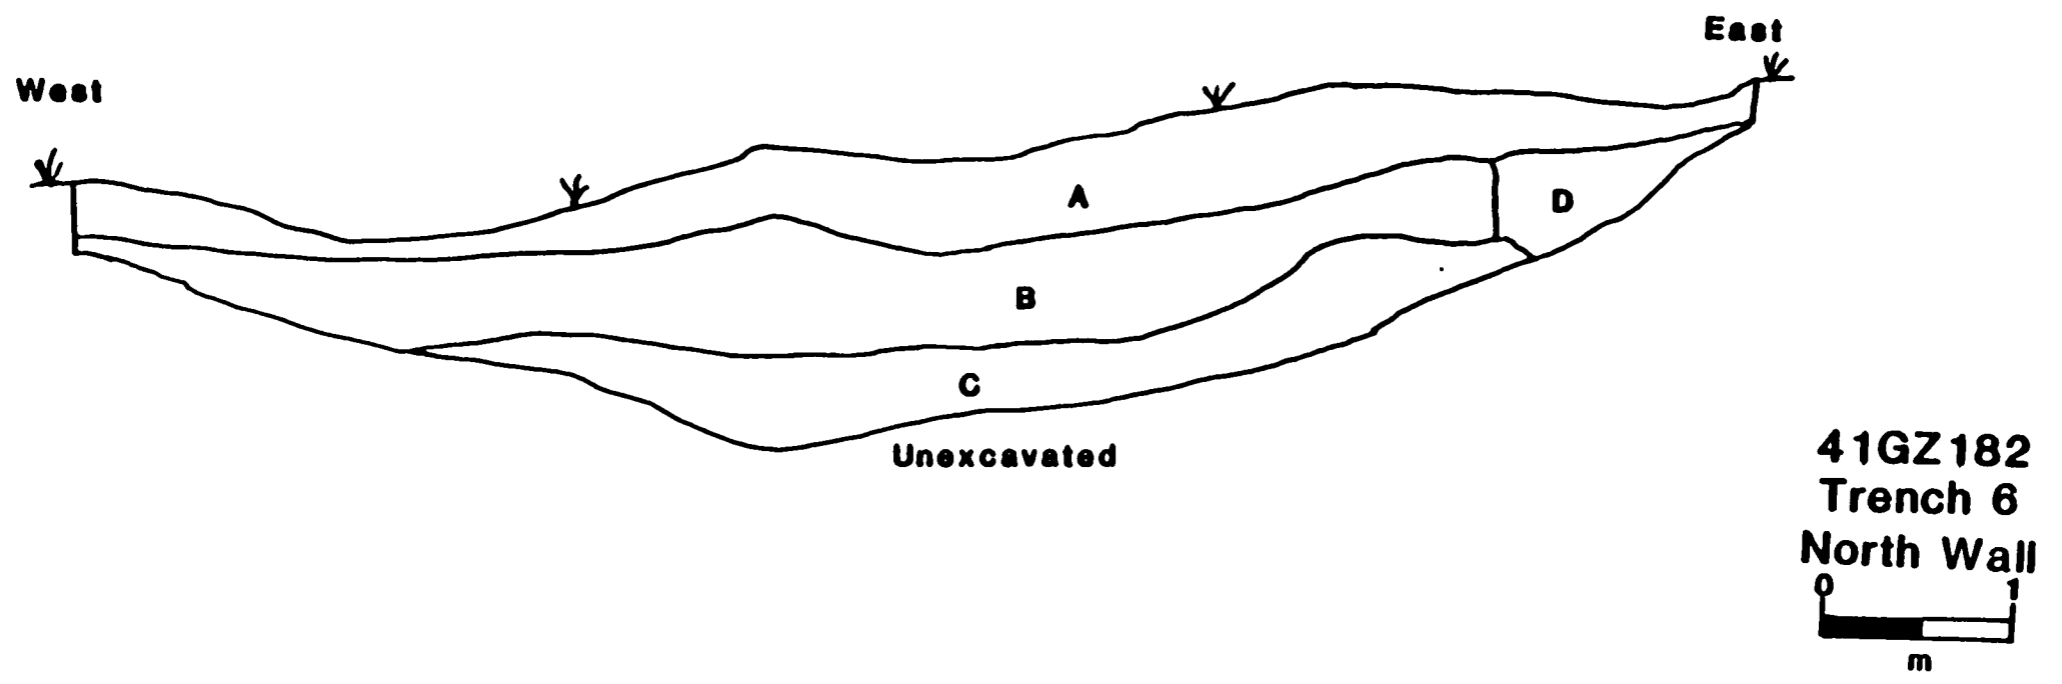
Figure 10. Profile of the north wall of Trench 6.

This trench was excavated with the backhoe and was 8.5 m long. The purpose of the trench was to determine the nature of the depression that is located north of the blockhouse depression (see Figure 4). Four zones were exposed, and only one (D) showed any unconformity (Figure 10). Zone A is a loose, dark brown (7.5YR3/2) sandy clay loam. This rests on Zone B which is a mottled caliche that is white (7.5YR8/0) with strong brown (7.5YR5/8) mottles. On the eastern end of Zone B, it

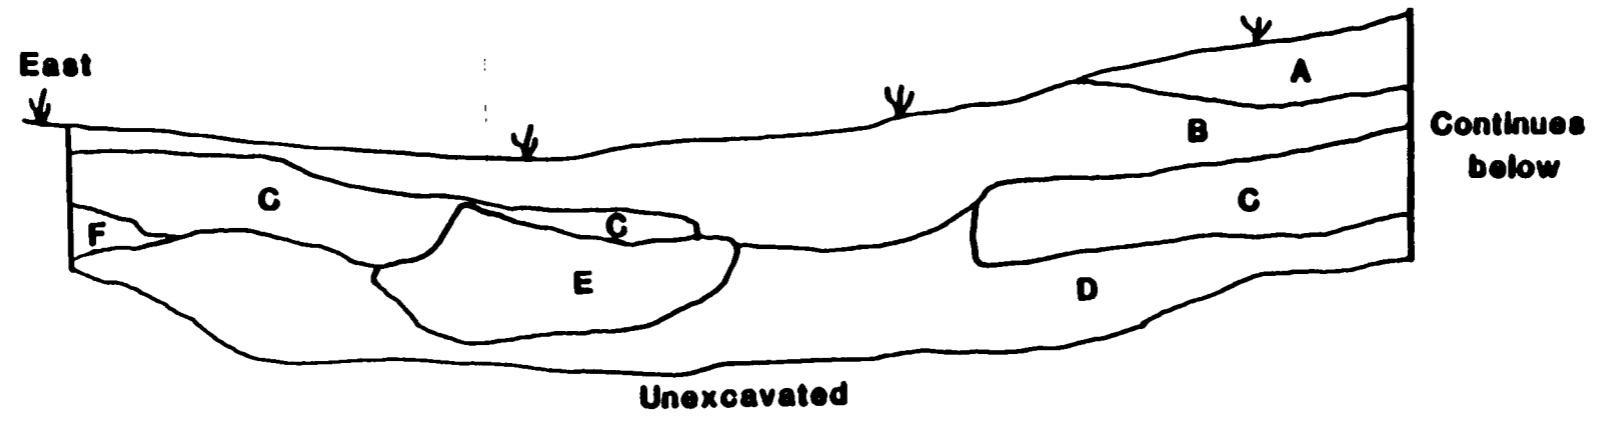
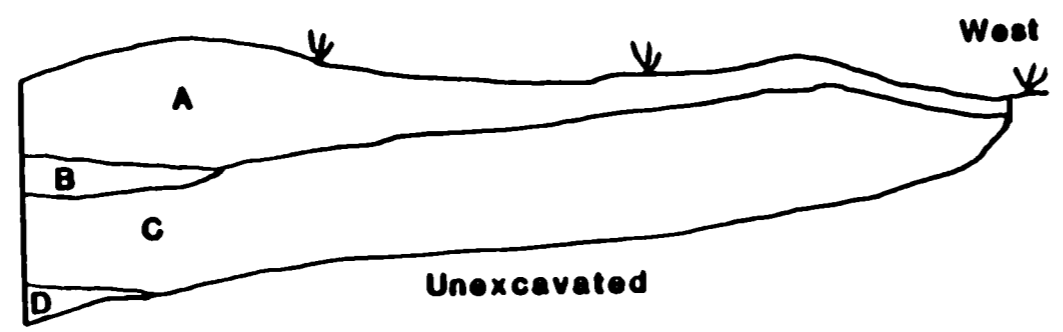
41GZ182  
Trench 7  
South Wall

Figure 11. Profile of the south wall of Trench 7.

This trench was placed just north of Trench 1 for the purpose of exploring the profile of the scarp and counterscarp outside the eastern wall of the earthworks (Figure 4). The trench was just over 12 m long and was dug with a backhoe. The results of the trench are similar to those of Trench 1. Zone A is the top of the earthworks and is truncated on the outside of the earthworks (Figure 11). It is light yellowish-brown (10YR6/4) in color and is a sandy clay. Zone B underlies A and has eroded into the ditch depression. This is a dark brown (7.5YR3/2) sandy clay. This may be its original geological position. Zone C is a sandy clay with gravel and is also dark brown in color.

Zone D underlies C and is a native clay that is light yellowish-brown (10YR6/4). This corresponds to the clay in the base of Trench 6 which is to the southwest. Zone E is a concentration of ash in the ditch depression. The fill is white (2.5YR8/0) and pinkish-gray (7.5YR7/2) in color. Zone F is a small area of caliche that is white with strong brown mottles (7.5YR8/0 with 7.7YR5/8). It corresponds to Zone B in Trench 6.

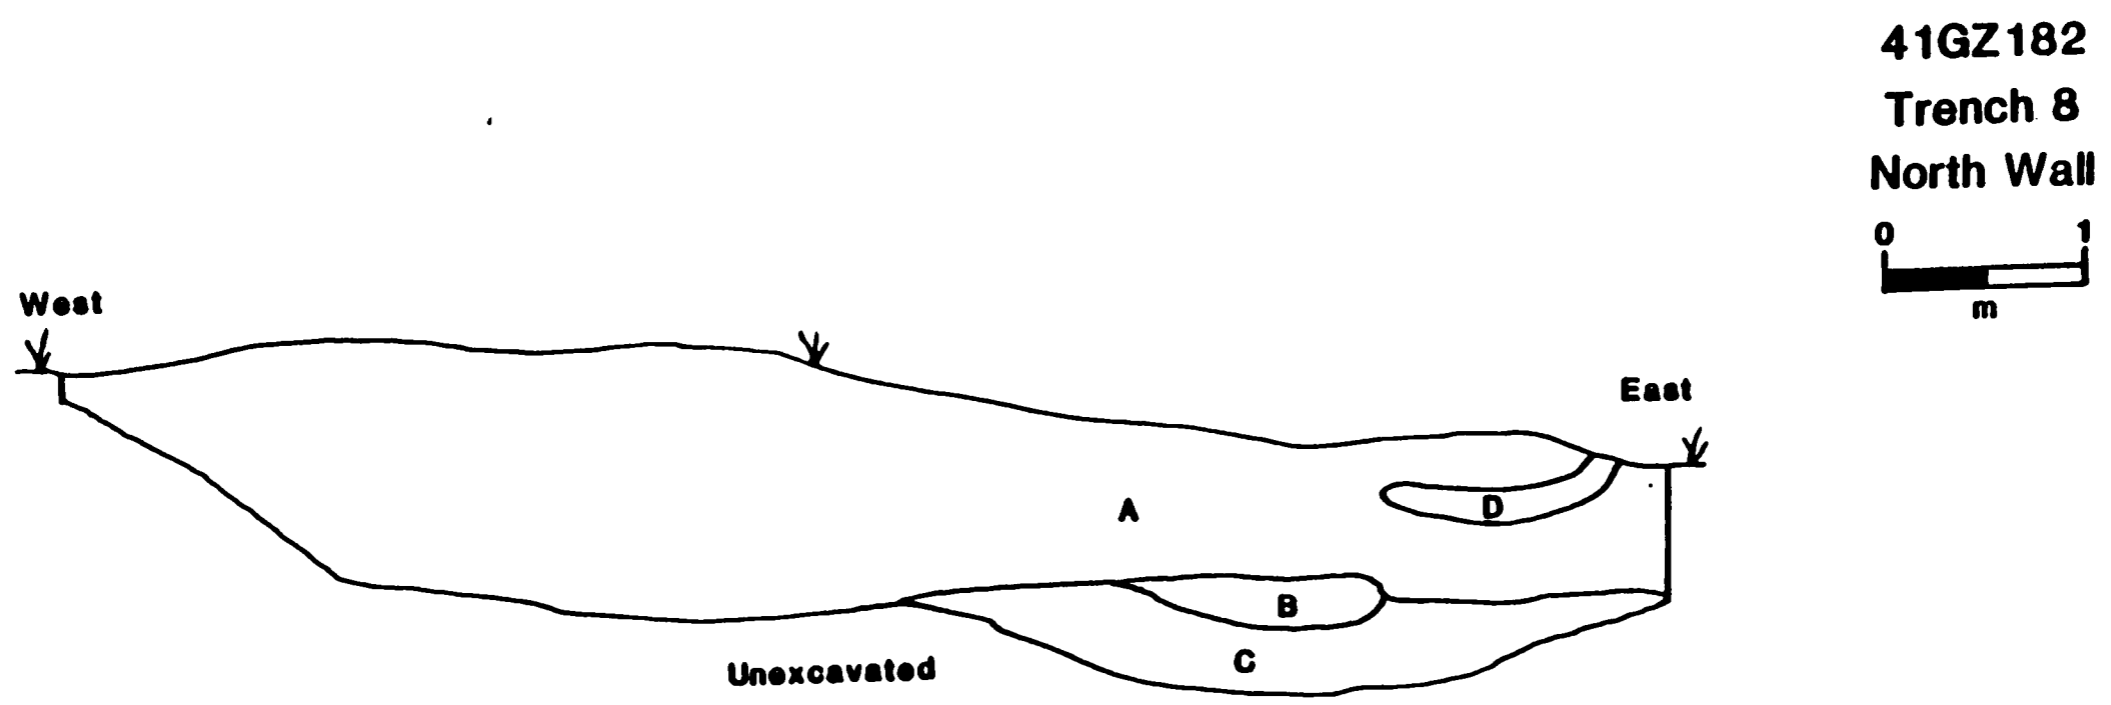
Figure 12. Profile of north wall of Trench 8.

This 8.3 m long backhoe trench was dug in the wall of the northeast bastion (see Figure 4). Four zones were uncovered in the north wall of the trench (Figure 12). Zone A is a very gravelly, sandy clay matrix which is dark brown (7.5YR3/2) in color. This was the fill used to construct the earthworks. However, since construction abandonment has eroded and covered the fill of the scarp and counterscarp. No visual break could be made between the slope of the earthworks and the fill which has eroded and covered Zone B. Zone B is an ashy layer that was in the ditch. The zone is white (2.5Y8/0) in color. The lowest zone (C) is a light yellowish-brown (10YR6/4) clay that underlies most of the northern half of the fort area. A small intrusion was recorded as Zone D. This zone is a strong brown (7.5YR4/6) color.

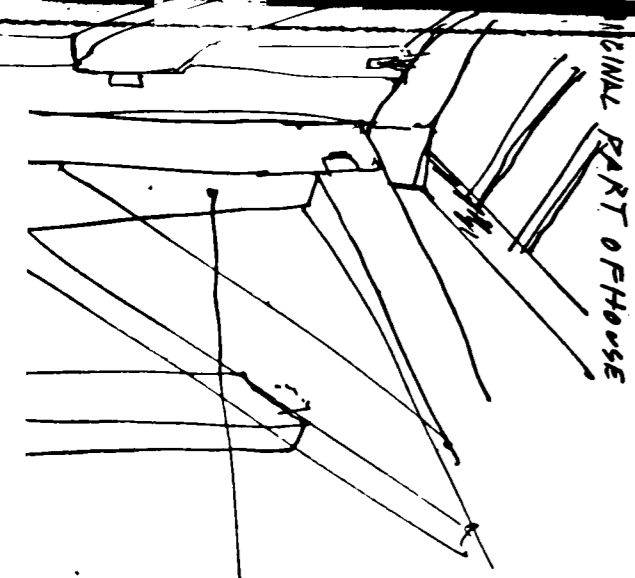
DETAIL  
TYPICAL PART OF HOUSE

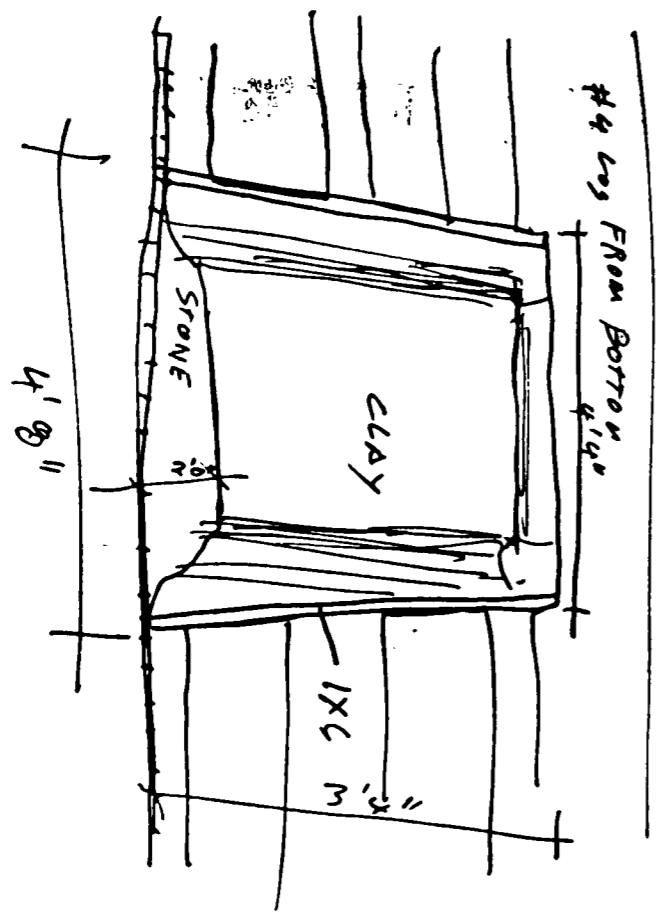
FIRE PLACE  
DETAIL

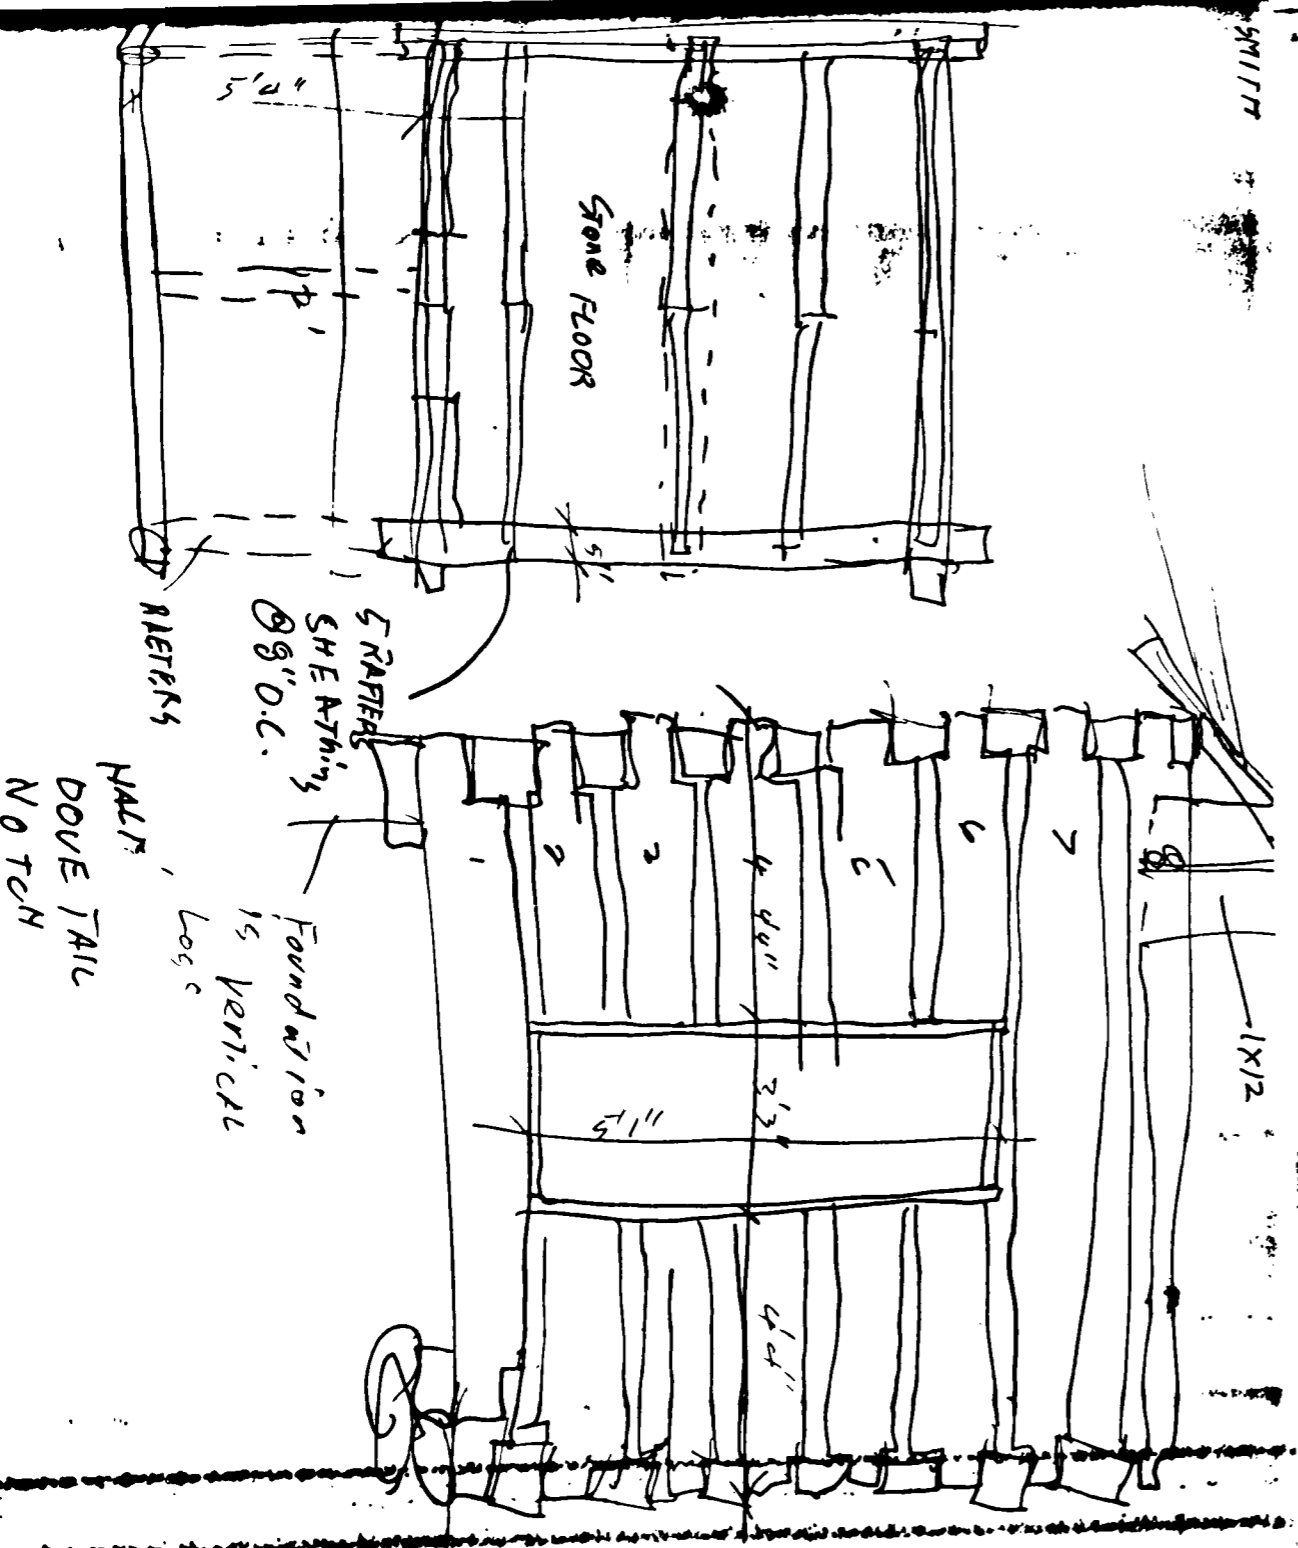
WALT  
DOVE TAIL  
NOTCH

5 RAPTER  
SHEATHING  
@ 9" O.C.  
FOUNDATION  
IS VERTICAL  
LOGS

STONE FLOOR

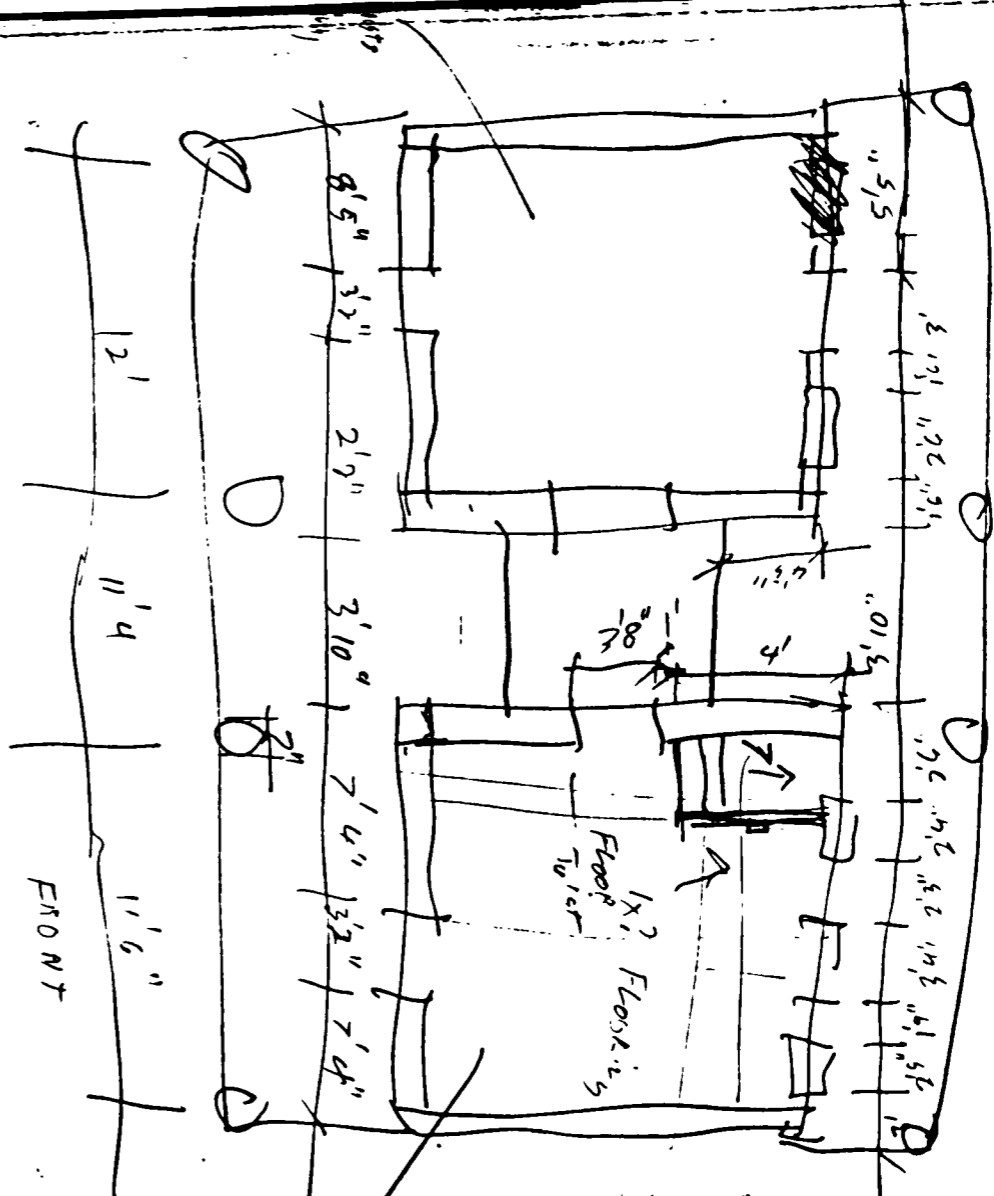
DETAIL OF  
MIDDLE  
END &  
AFTER

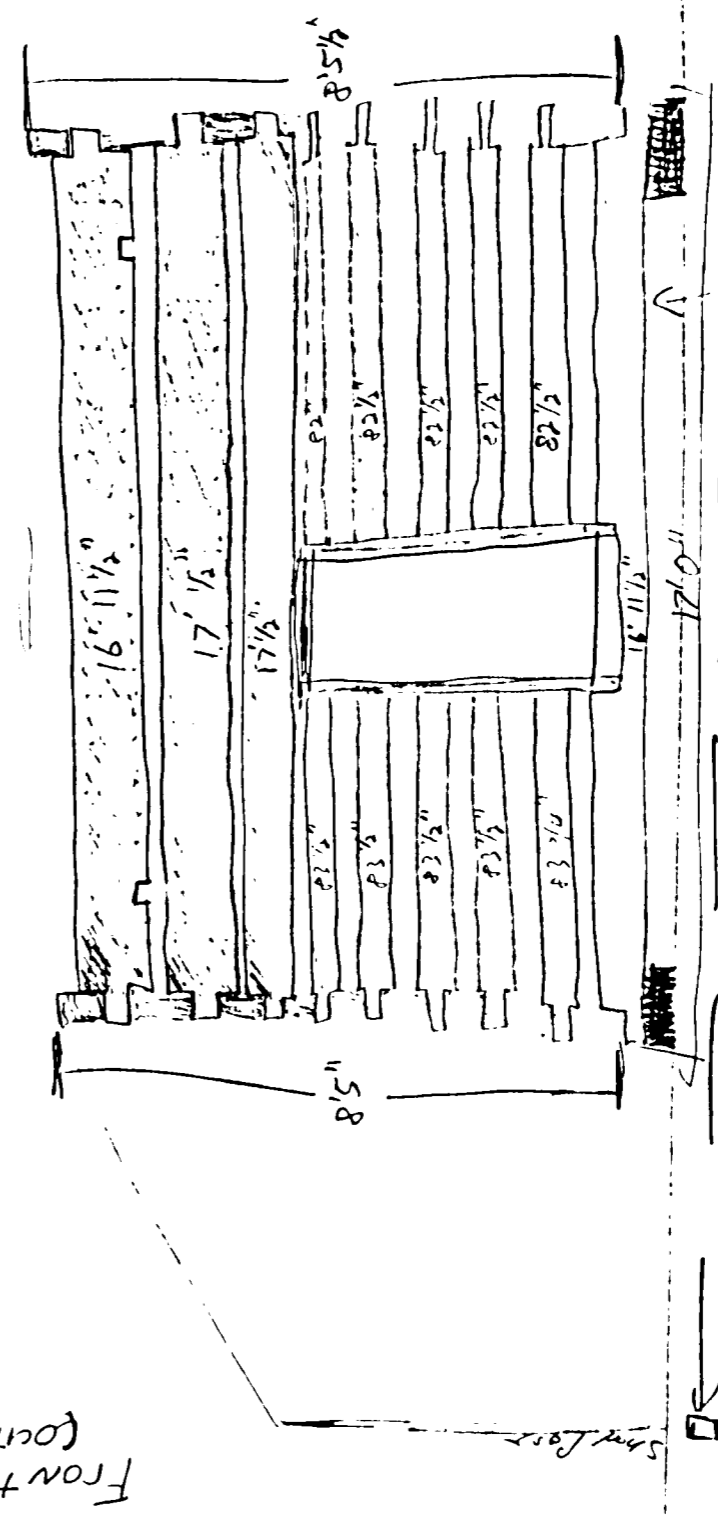
Replace all logs on front  
except sponner

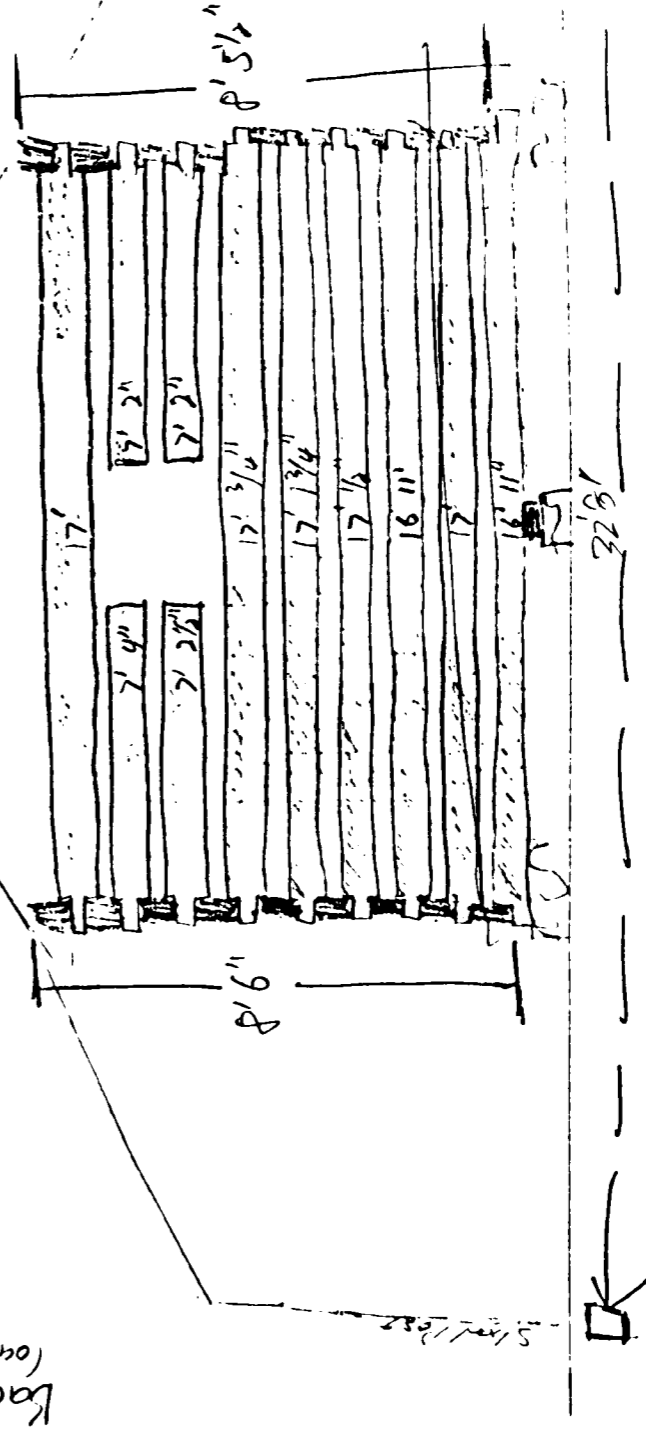
Back (outside view)

all logs good  
 Top log has split face pointed out

SIDE EL

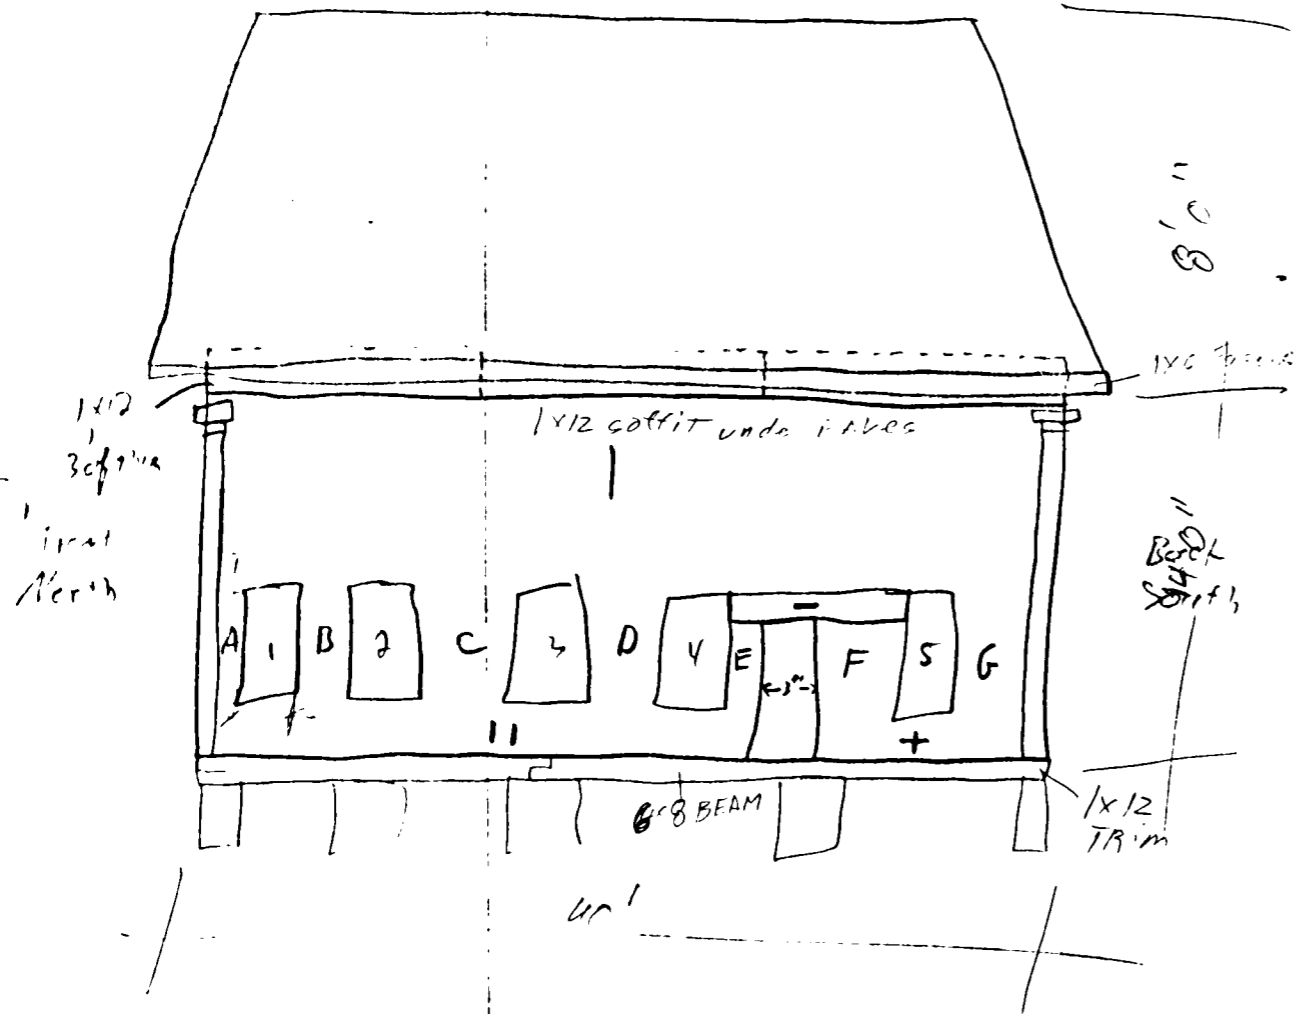
West - Right

Best log measurement 50 1/2"

8'6" & 5 1/2"  
 measured inside to Floor

Letters in Blue  
mark " "

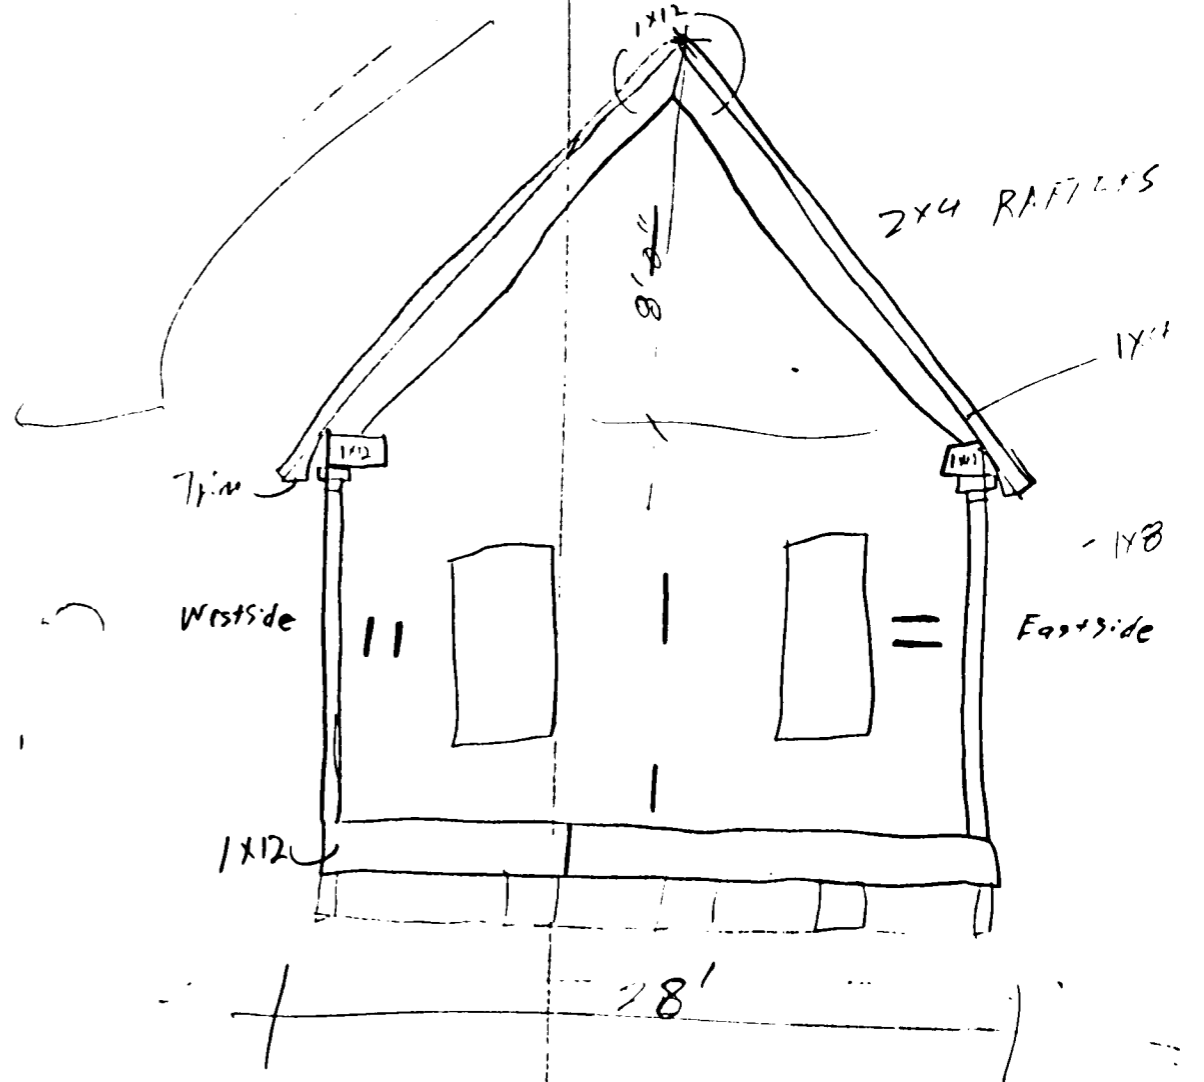
Back-South

Front  
North
